# FORMER TAXATION BUILDING: FEASIBILITY STUDY

MAY 1, 2024

## II. EXECUTIVE SUMMARY

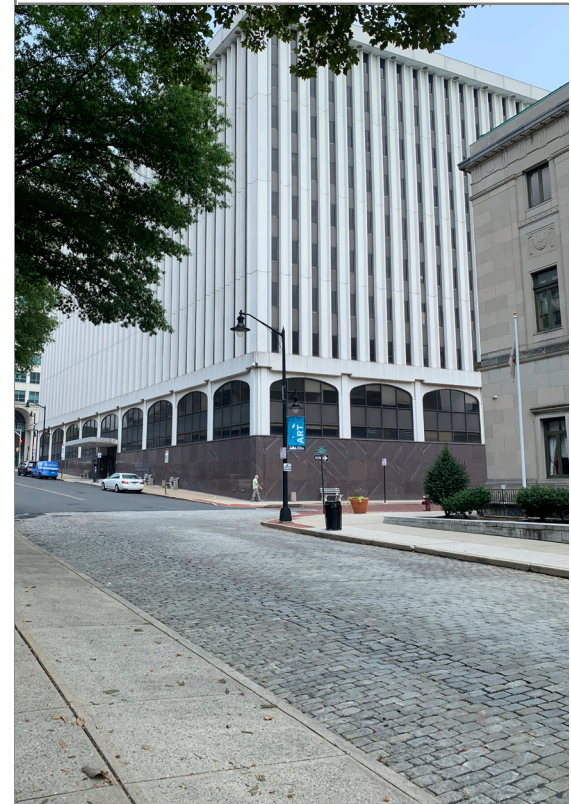
View of the former Taxation Building looking northeast from Barrack Street

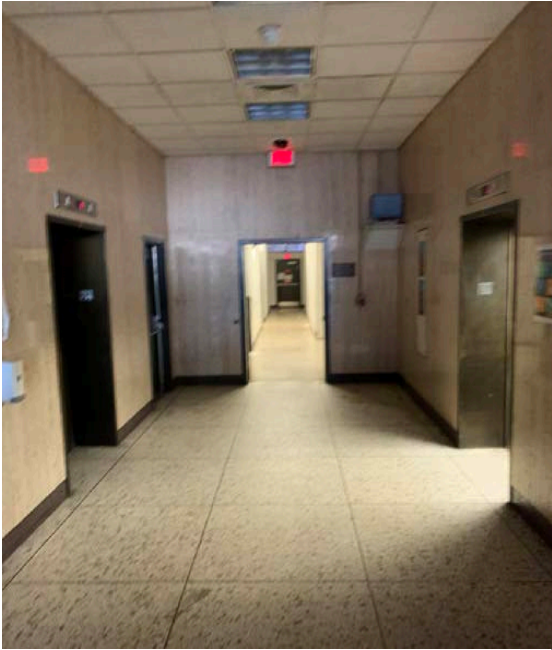
Elevator lobby of the former Taxation Building; the floors and walls are clad with travertine marble

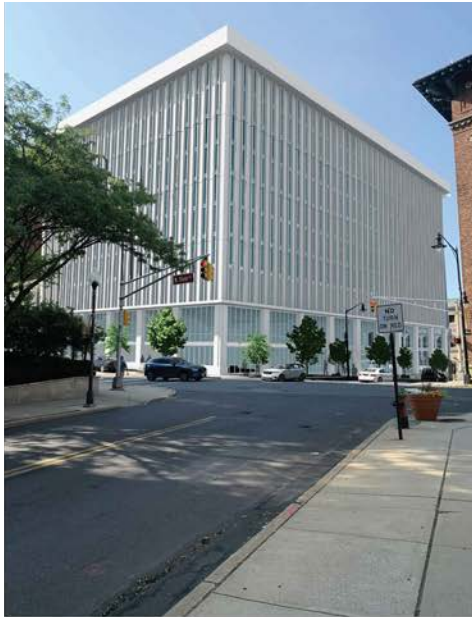
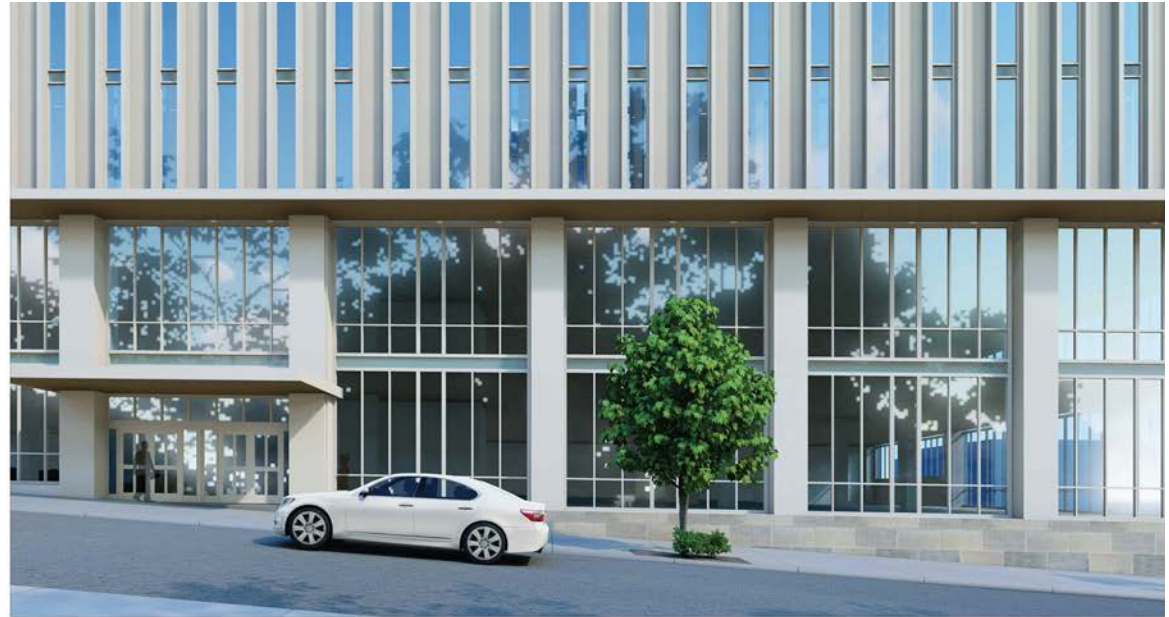
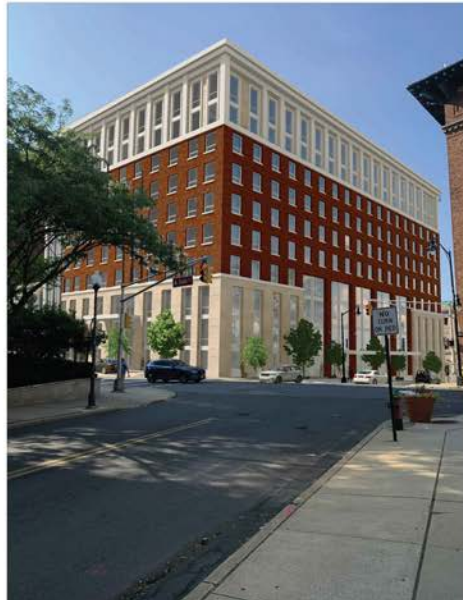
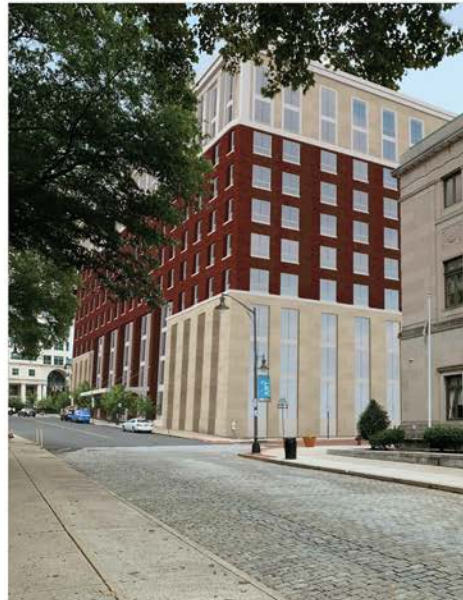
Renderings of different options for re-cladding the exterior of the former Taxation Building

CCH also developed a number of options for renovating the exterior of the building, ranging from straightforward window replacement to more dramatic exterior changes. These are shown to address potential concerns about both the energy performance of the exterior and its overall appearance.

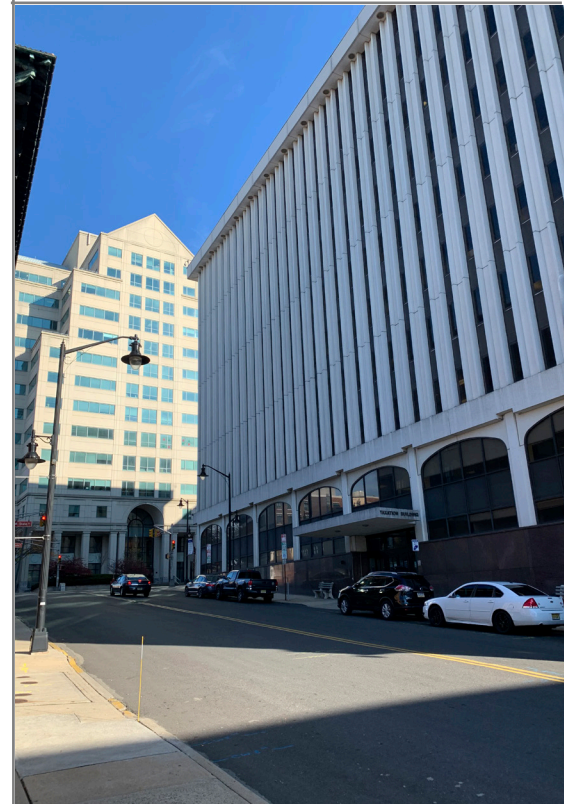
View of the main entrance to the former Taxation Building along Barrack Street

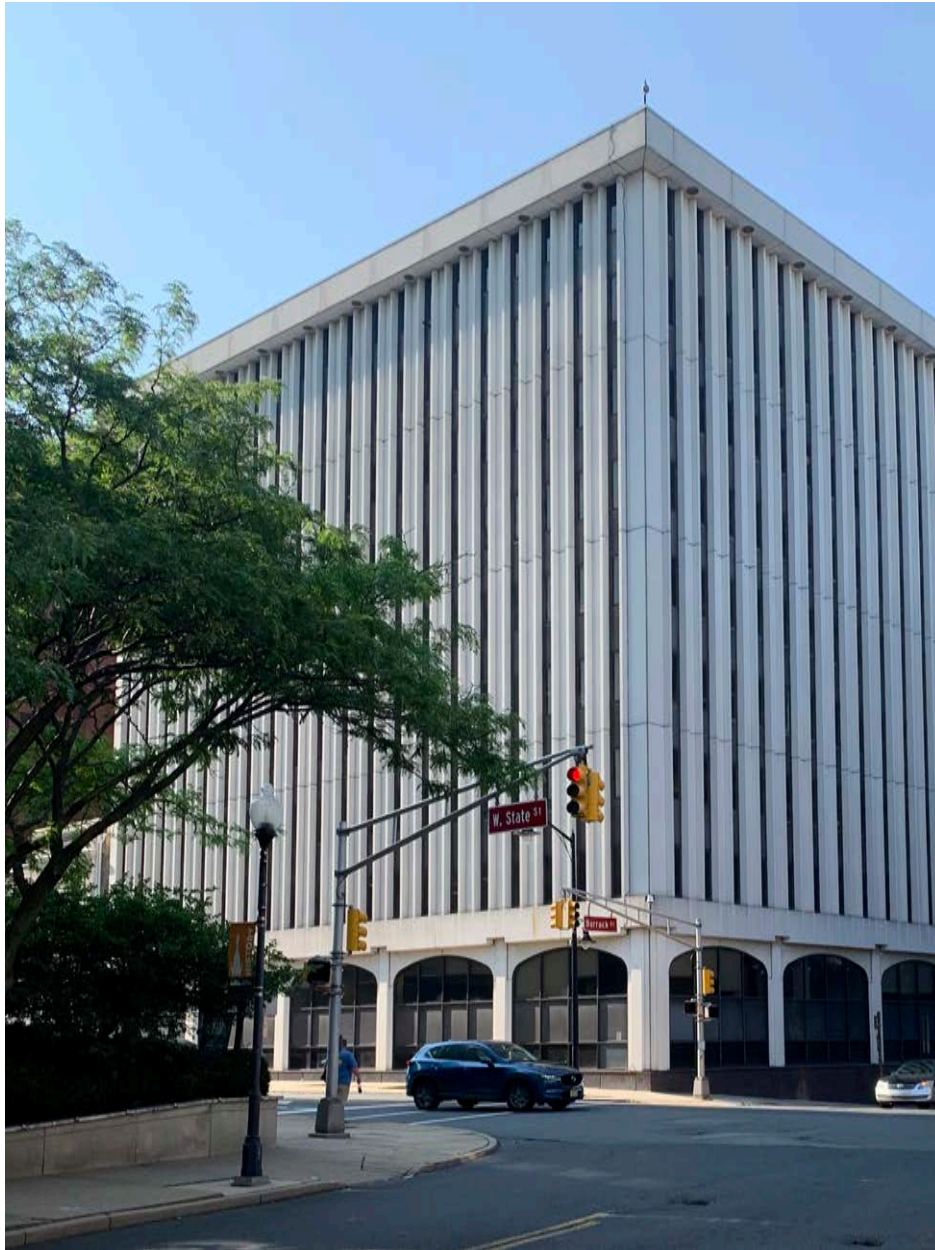
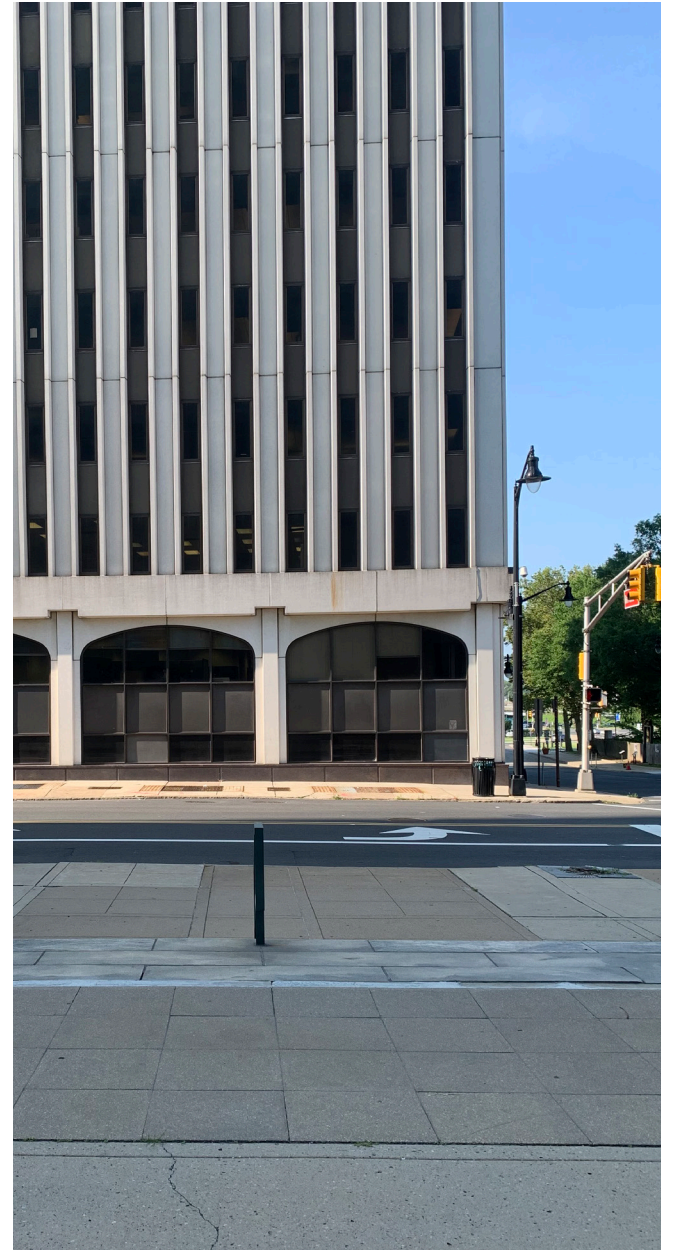
## Former Taxation Building - Barrack Street Elevation

Feature	Description	Condition	Recommendations
Sidewalk	Concrete	Fair	Some tripping hazards; repair/ replace. Add street trees.
Base	Polished black granite	Fair to good	Some cracking and damage; needs to be repointed. See renderings recommending replacement and reconfiguration. Note that the granite is applied to a concrete block back-up wall. The height of the granite cap is constant even through the site has a dramatic grade change.
Piers	Pre-cast concrete	Very good	Some elevation concepts suggest removing and replacing with other materials some or all of the piers. Note that these solid portions of the facades do not appear to have any insulation. If the facade is maintained, additional wall furring with continuous and non-continuous insulation should be considered along with an analysis for an appropriate air and vapor barrier.
Windows	Single pane, aluminum framed	Poor	Some of these are leaking; all are single pane, not-thermally broken, inefficient and have reached the end of their useful lives. The frames appear to be connected to the concrete facade. Replace.

Spandrel	Black glass	Poor	Some of these are leaking; all are single pane, inefficient and have reached the end of their useful lives. Replace.
Cornice	Pre-cast concrete	Good	Some minor staining which could likely be cleaned.
Exterior lights	Large recessed lights at the underside of the cornice	Fair	Many are no longer working. Replace with LED retrofits as part of exterior upgrade.
Doors	Aluminum and glass entry doors at the main entry	Fair	Replace as part of exterior upgrade.
Canopy	Reinforced Concrete	Fair to good	Clean, patch as required and provide new signage.

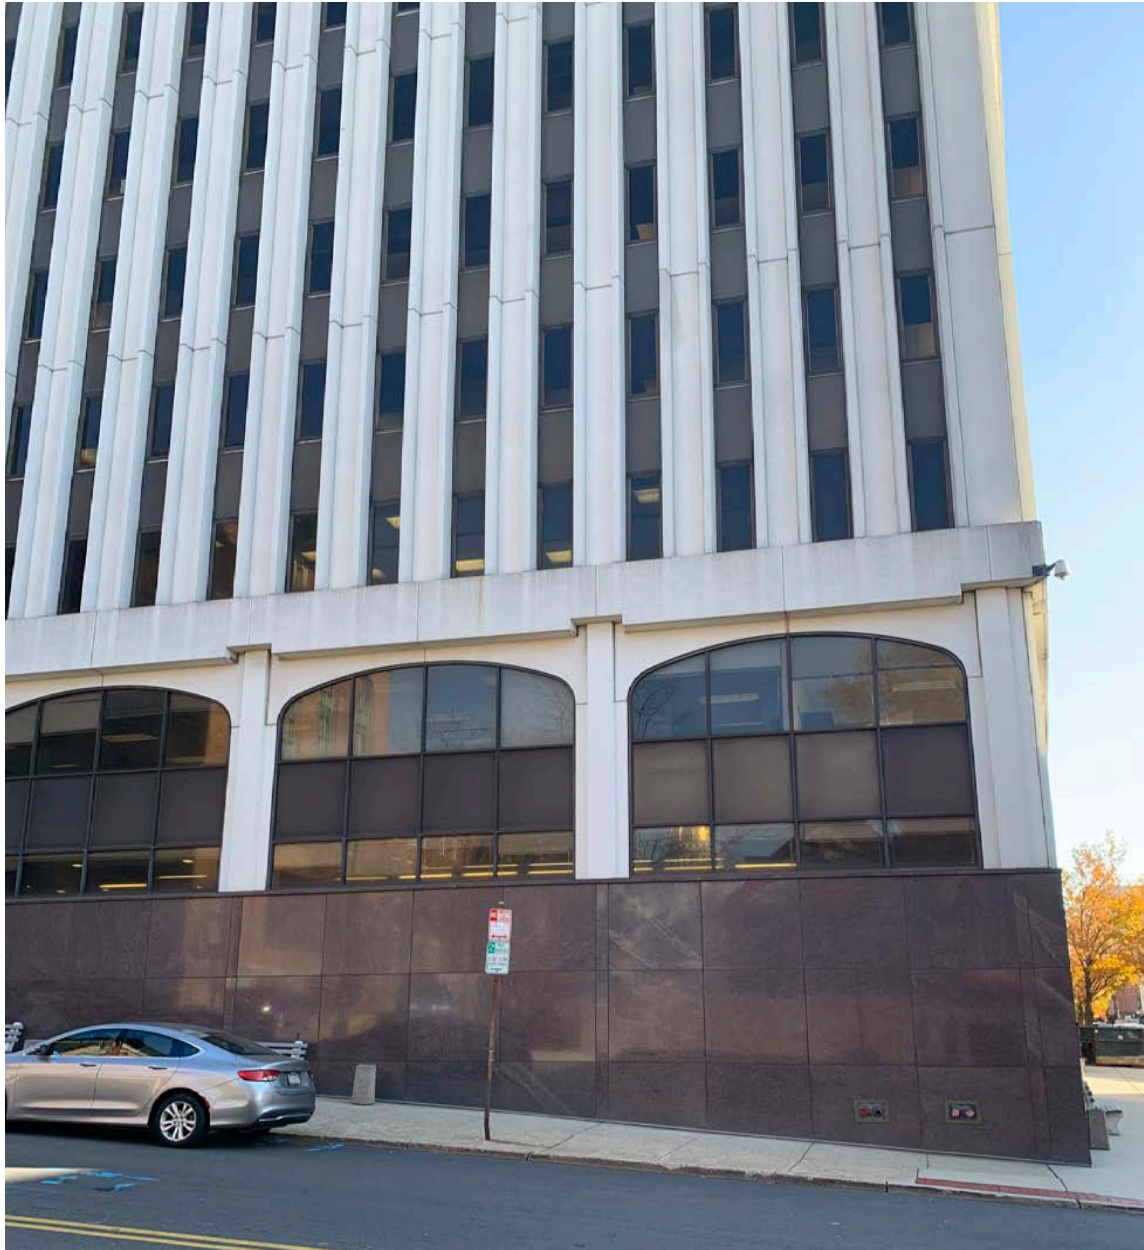
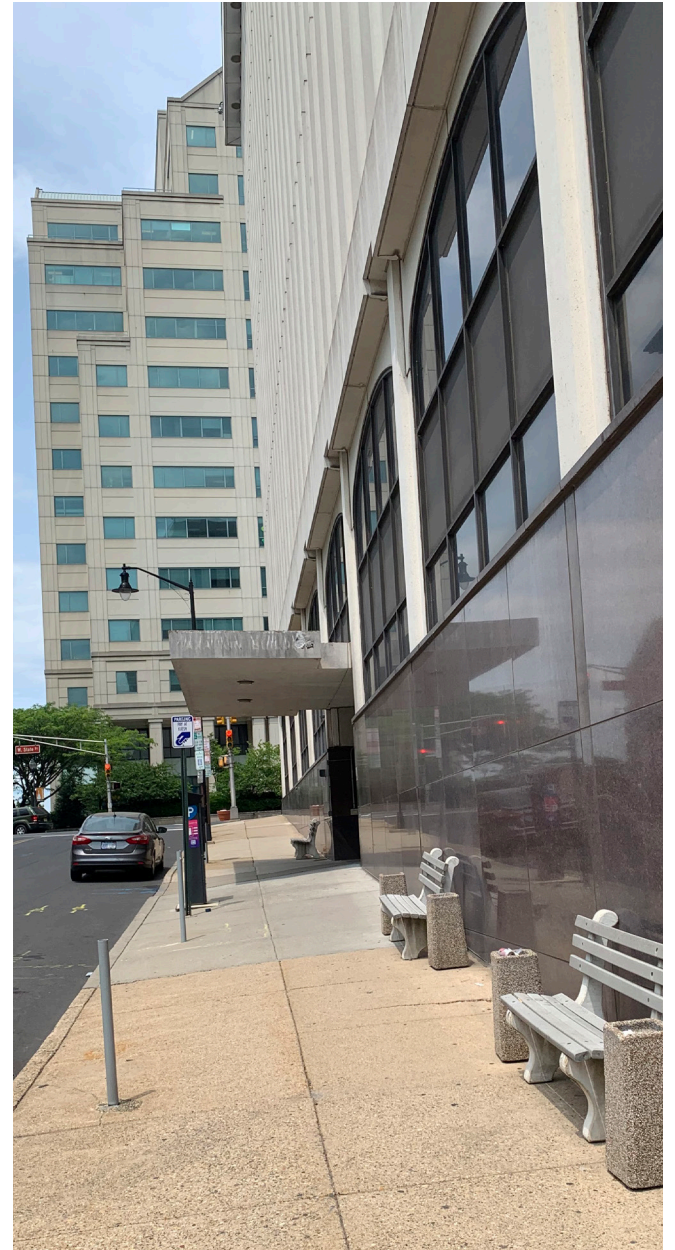
## Former Taxation Building - Front Street Elevation

Feature	Description	Condition	Recommendations
Sidewalk	Concrete	Fair	Some tripping hazards; repair/ replace. Add street trees.
Base	Polished black granite	Fair to good	Some cracking and damage; needs to be repointed. See renderings recommending replacement and reconfiguration
Piers	Pre-cast concrete	Very good	Some elevation concepts suggest removing and replacing with other materials some or all of the piers. Note that these solid portions of the facades do not appear to have any insulation. If the facade is maintained, additional wall furring with continuous and non-continuous insulation should be considered along with an analysis for an appropriate air and vapor barrier.
Windows	Single pane, aluminum framed	Poor	Some of these are leaking; all are single pane, not-thermally broken, inefficient and have reached the end of their useful lives. The frames appear to be connected to the concrete facade. Replace.

Spandrel	Black glass	Poor	Some of these are leaking; all are single pane, inefficient and have reached the end of their useful lives. Replace.
Cornice	Pre-cast concrete	Good	Some minor staining which could likely be cleaned.
Exterior lights	Large recessed lights at the underside of the cornice	Fair	Many are no longer working. Replace with LED retrofits as part of exterior upgrade.
Doors	Metal garage doors	Fair	Replace with insulated doors as part of exterior upgrade.

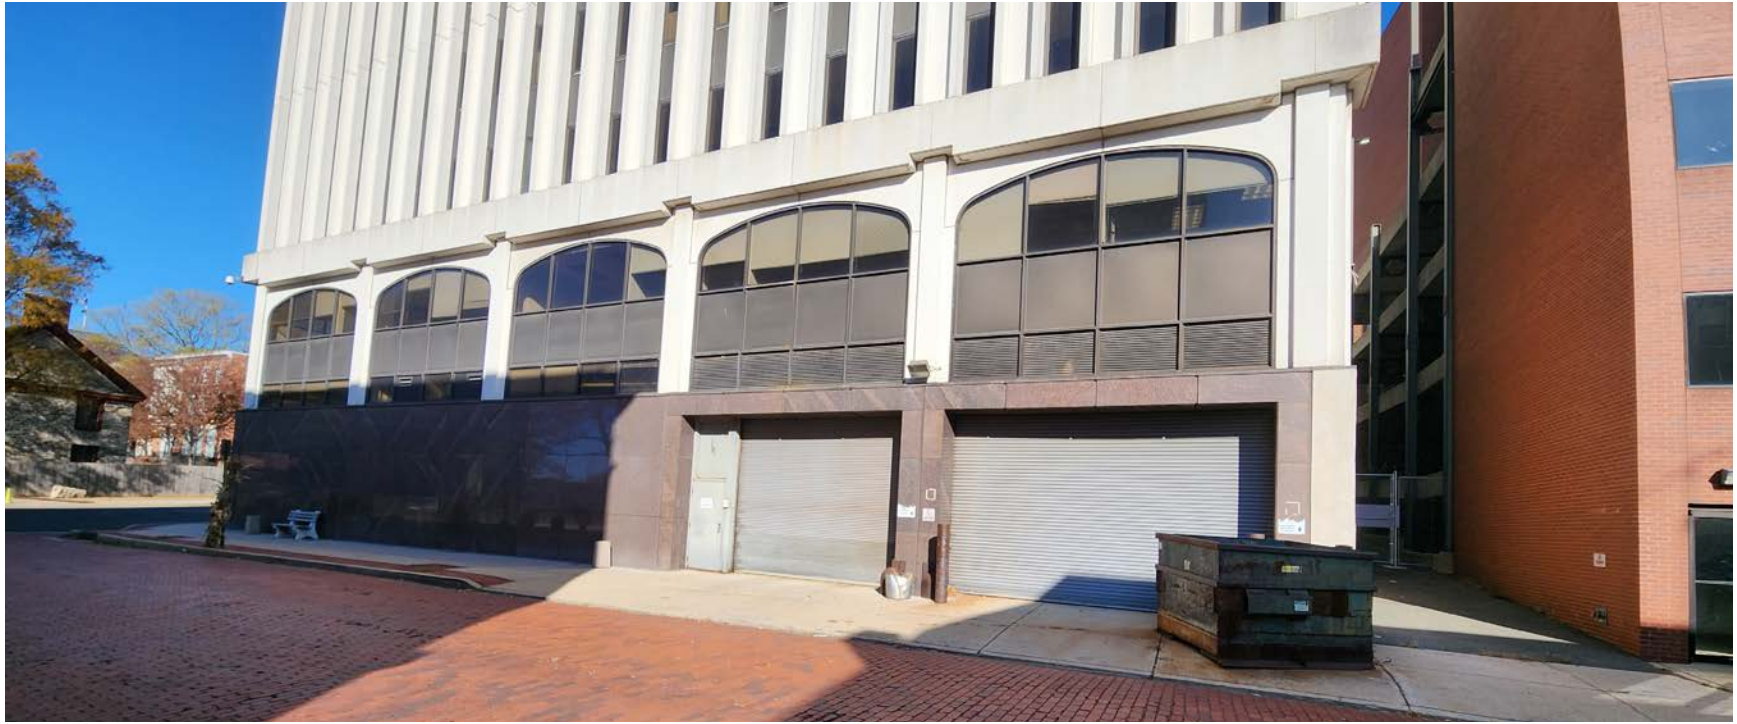
## Former Taxation Building - Alley Elevation

Feature	Description	Condition	Recommendations
Alley sidewalk and stairs	Concrete; used for egress from the building. Gates located at both ends.	Good	Clean; some minor repairs needed.
Base	Polished black granite	Fair to good	Some cracking and damage; needs to be repointed. See renderings recommending replacement and reconfiguration
Piers	Pre-cast concrete	Very good	Some elevation concepts suggest removing and replacing with other materials some or all of the piers. Note that these solid portions of the facades do not appear to have any insulation. If the facade is maintained, additional wall furring with continuous and non-continuous insulation should be considered along with an analysis for an appropriate air and vapor barrier.
Masonry exterior wall	Brick	Fair to good	Repoint as required
Windows	Single pane, aluminum framed	Poor	Some of these are leaking; all are single pane, not-thermally broken, inefficient and have reached the end of their useful lives. The frames appear to be connected to the concrete facade. Replace with operable, insulated windows.

Spandrel	Black glass	Poor	Some of these are leaking; all are single pane, inefficient and have reached the end of their useful lives. Replace.
Cornice	Pre-cast concrete	Good	Some minor staining which could likely be cleaned.
Exterior lights	Large recessed lights at the underside of the cornice	Fair	Many are no longer working. Replace with LED retrofits as part of exterior upgrade.
Doors	Painted hollow metal egress doors	Fair	Replace as part of exterior upgrade.

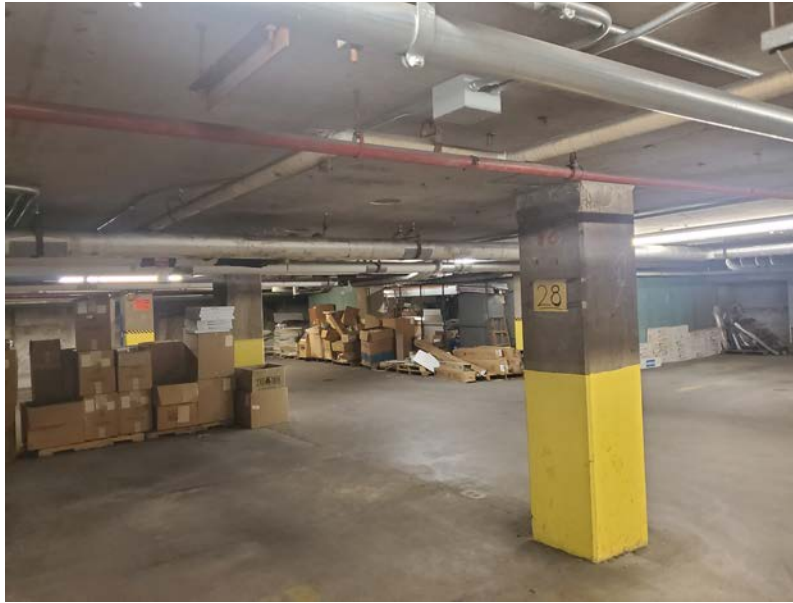
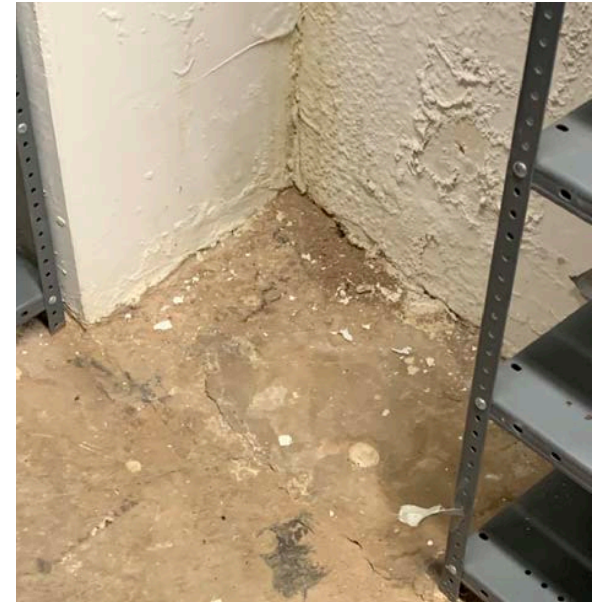
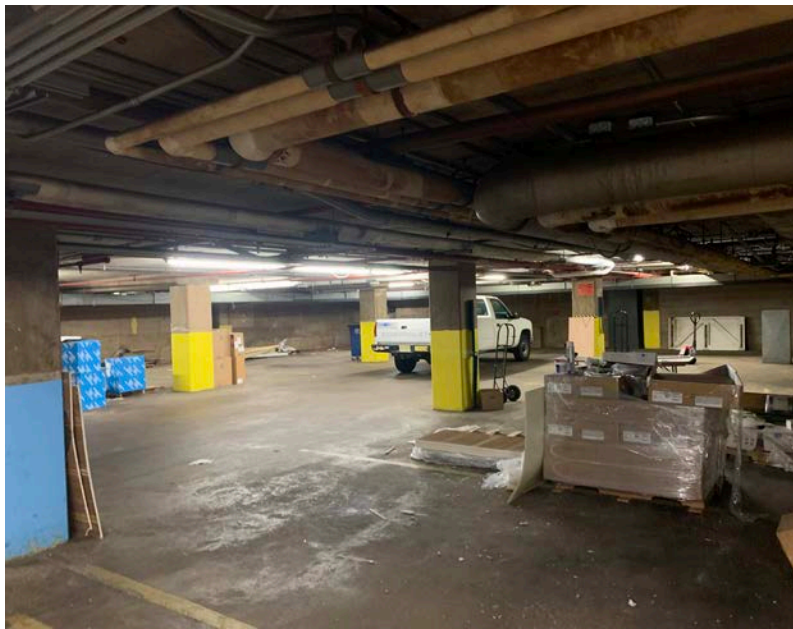
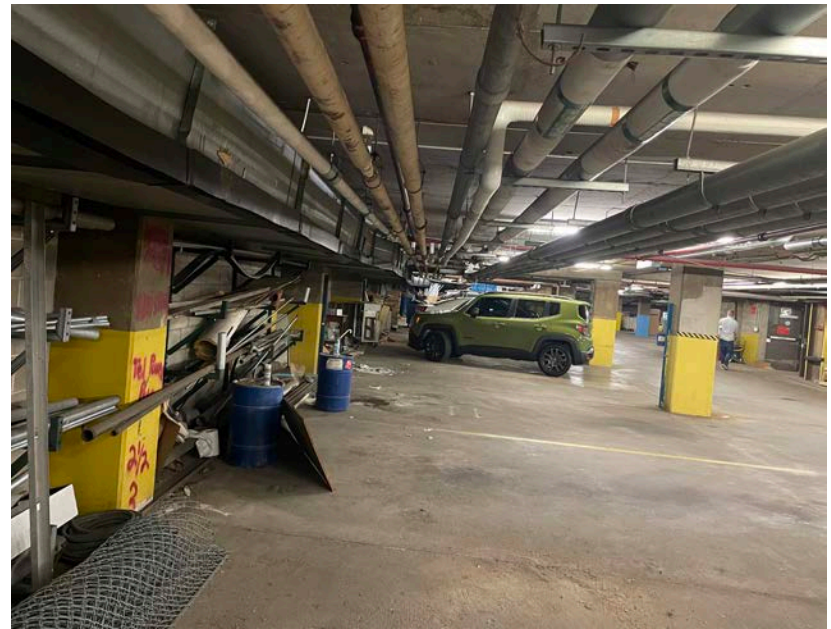
## Former Taxation Building - Basement Conditions

Feature	Description	Condition	Recommendations
Floors	VCT (vinyl composition tile, typ.)	Poor	Remove and replace
	Ceramic Tile (in restrooms)	Fair	Replace as part of renovations
	Exposed concrete	Fair	New traffic coating should be applied
	Striping	Poor	Re-stripe as required for the new layout
Walls	Concrete/ CMU	Good	Repaint as necessary
	Drywall	Poor to good	Interior partitions can be replaced
Ceilings	ACT (acoustic ceiling tile, typ.)	Fair	Remove all ACT ceilings; replace where desired
	Exposed Concrete	Very good	Finish as desired
Base	Vinyl	Fair to poor	Remove; replace where appropriate
Elevators	Existing cabs and equipment	Fair	Elevator cabs should be upgraded and replaced
Doors	Painted hollow metal	Fair	Repair or replace as part of renovations
Columns	Concrete	Good	These can be left bare or finished as appropriate for the proposed renovations.

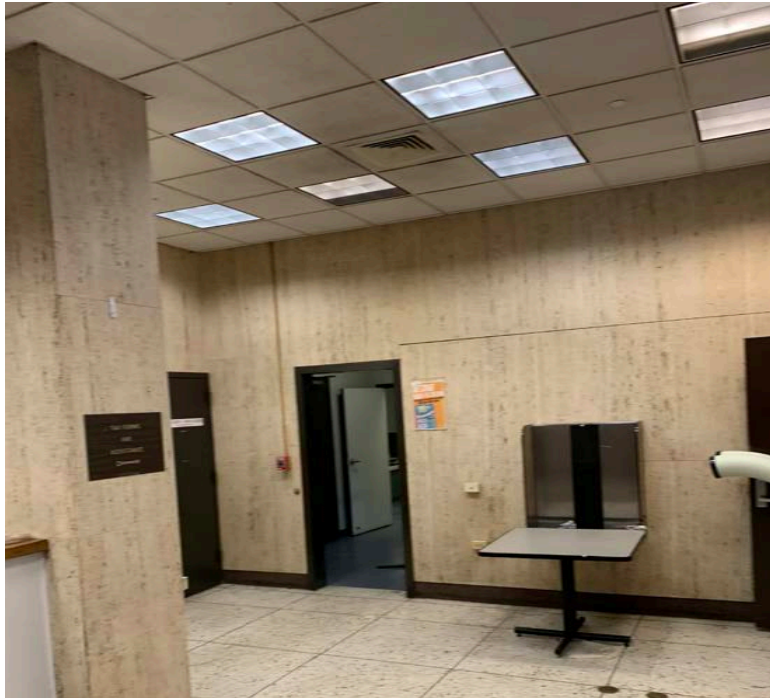
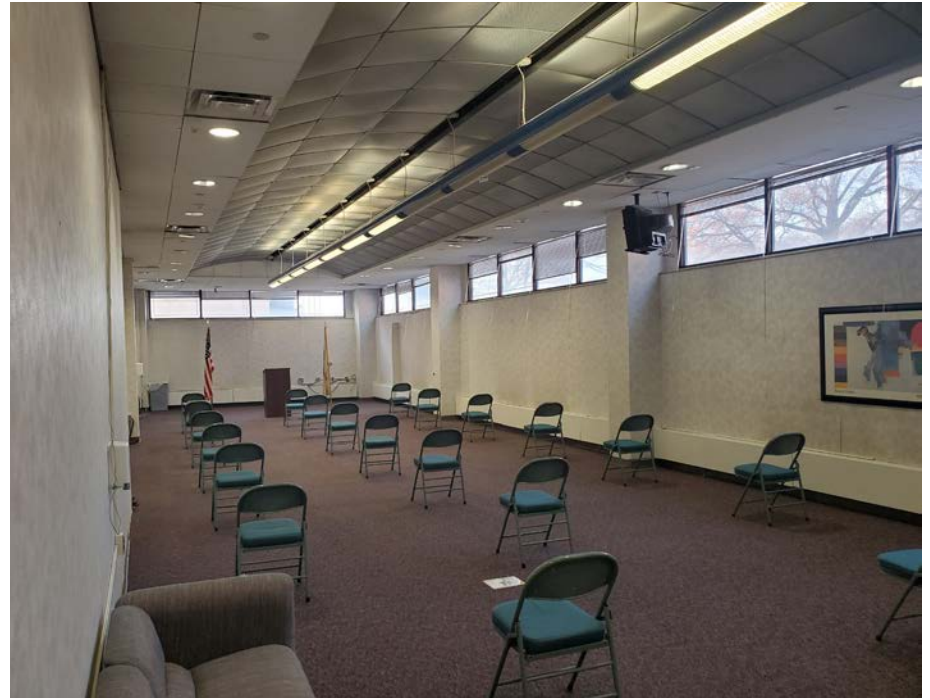
## Former Taxation Building - First Floor Conditions

Feature	Description	Condition	Recommendations
Floors	Travertine	Good	This is a feature that could be kept as part of the renovations
	VCT	Poor	Remove and replace
	Ceramic Tile (in restrooms)	Fair	Replace as part of renovations
	Raised Floor in the former computer room	Fair	Remove
	Painted concrete	Fair	Where desired, concrete floors can be repainted or polished
	Carpet	Poor	Remove; replace where appropriate
Walls	Travertine	Good	This is a feature that could be kept as part of the renovations
	Drywall	Poor to good	Exterior walls are not insulated; remove and replaced exterior furring; most interior partitions can be replaced
Ceilings	ACT	Fair	Remove all ACT ceilings; replace where desired
	Concrete	Very good	Above the ACT ceilings, the concrete is in good condition. This can be cleaned and exposed where desired
Base	Travertine	Good	This is a feature that could be kept as part of the renovations
	Vinyl	Fair to poor	Remove; replace where appropriate

Elevators	Existing cabs and equipment	Fair	Elevator cabs should be upgraded and replaced
Doors	Painted wood and painted hollow metal	Fair	Replace as part of renovations
Columns	Travertine clad	Good	This is a feature that could be kept as part of the renovations
	Concrete	Good	These can be left bare or finished as appropriate for the proposed renovations.
Kitchen Equipment	Some remaining equipment in former kitchen	Fair	Remove and salvage

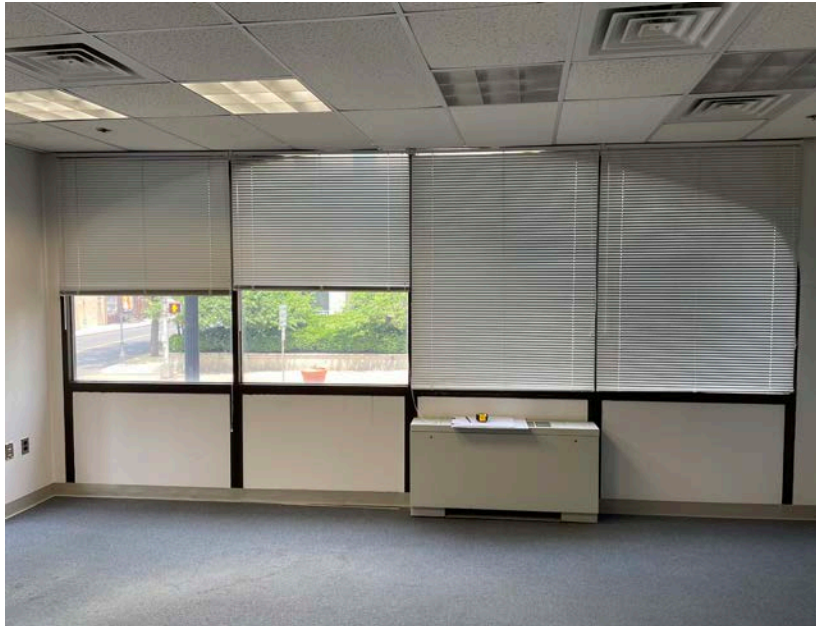
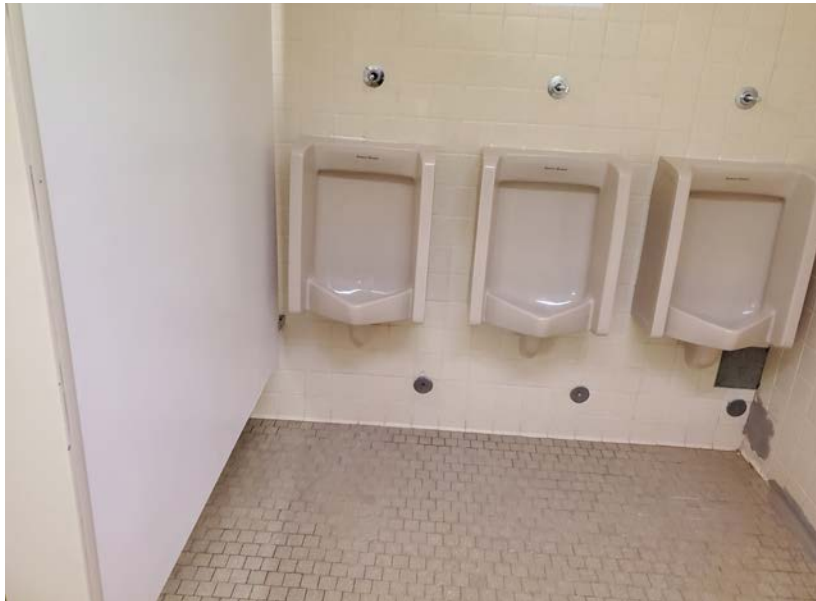
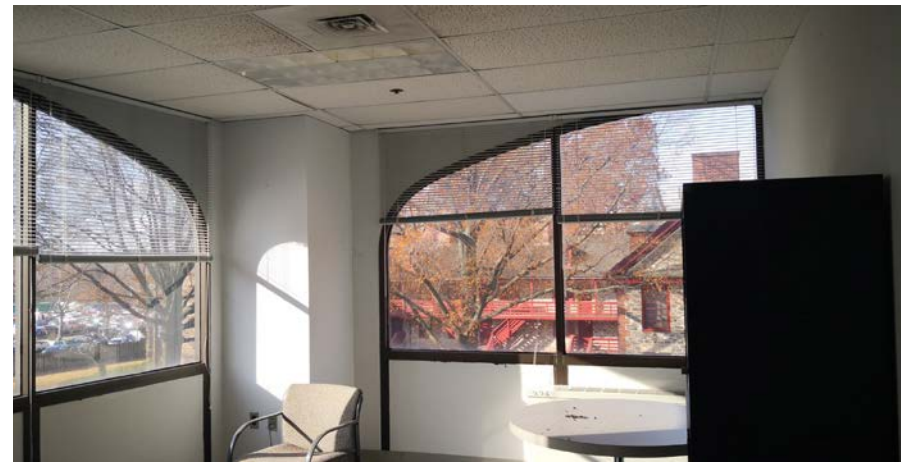
## Former Taxation Building - Second Floor Conditions

Feature	Description	Condition	Recommendations
Floors	VCT	Poor	Remove and replace
	Ceramic Tile (in restrooms)	Fair	Remove as part of renovations
	Painted concrete	Fair	Where desired, concrete floors can be repainted or polished
	Carpet	Poor	Remove; replace where appropriate
Walls	Drywall	Poor to good	Exterior walls are not insulated; remove and replace exterior furring and insulate; most interior partitions can be replaced
Ceilings	ACT	Fair	Remove all ACT ceilings; replace where desired
	Concrete	Very good	Above the ACT ceilings, the concrete is in good condition. This can be cleaned and exposed where desired
Base	Vinyl	Fair to poor	Remove; replace where appropriate
Soffits	Drywall	Fair	Replace where appropriate
Elevators	Existing cabs and equipment	Fair	Elevator cabs should be upgraded and replaced
Doors	Painted wood and painted hollow metal	Fair	Replace as part of renovations
Columns	Concrete with furring and drywall	Good	These can be left bare or finished as appropriate for the proposed renovations.

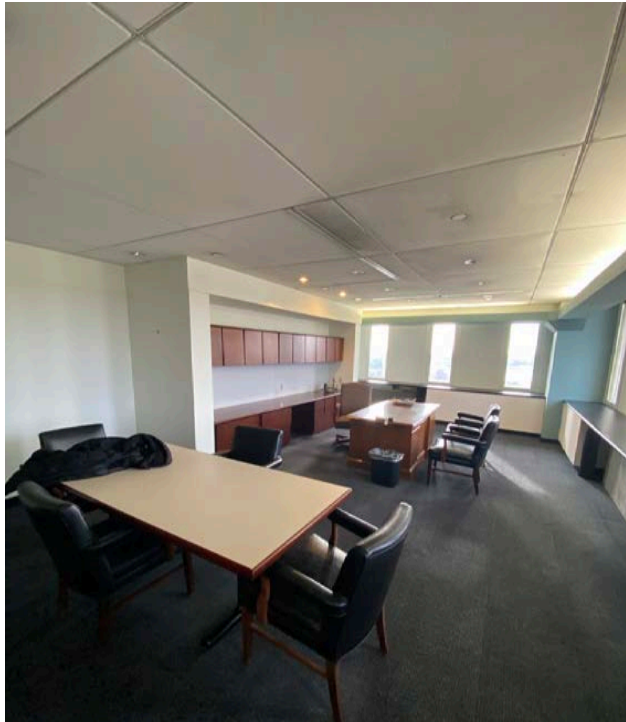
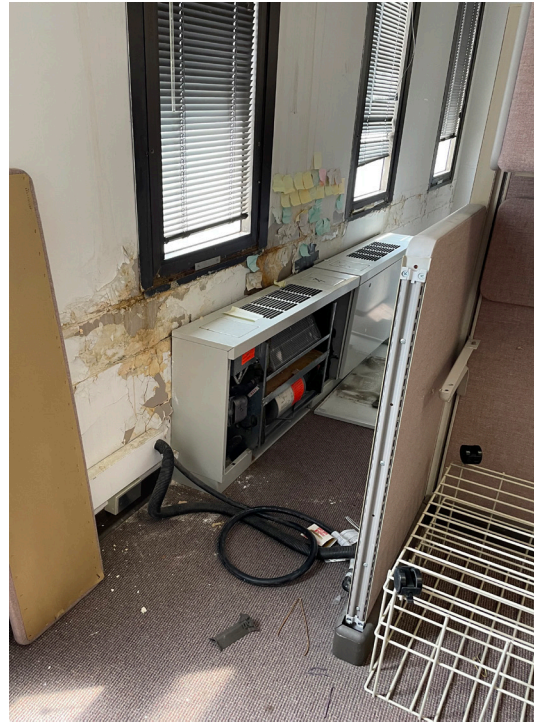
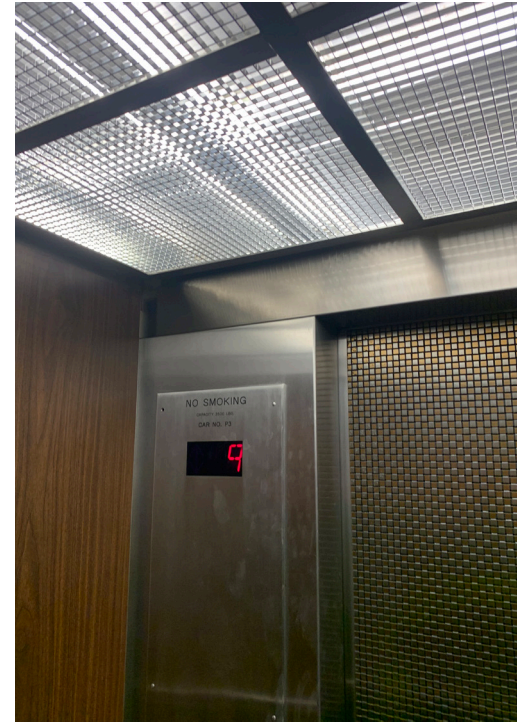
## Former Taxation Building - Floors Three to Ten Conditions

Feature	Description	Condition	Recommendations
Floors	VCT	Poor	Remove and replace
	Ceramic Tile (in restrooms)	Fair	Remove as part of renovations
	Painted concrete	Fair	Where desired, concrete floors can be repainted or polished
	Carpet	Poor	Remove; replace where appropriate
Walls	Drywall	Poor to good	Exterior walls are not insulated; remove and replace exterior furring and insulate; most interior partitions can be replaced
Ceilings	ACT	Fair	Remove all ACT ceilings; replace where desired
	Concrete	Very good	Above the ACT ceilings, the concrete is in good condition. This can be cleaned and exposed where desired
Base	Vinyl	Fair to poor	Remove; replace where appropriate
Soffits	Drywall	Fair	Replace where appropriate
Elevators	Existing cabs and equipment	Fair	Elevator cabs should be upgraded and replaced
Doors	Painted wood and painted hollow metal	Fair	Replace as part of renovations
Columns	Concrete with furring and drywall	Good	These can be left bare or finished as appropriate for the proposed renovations.

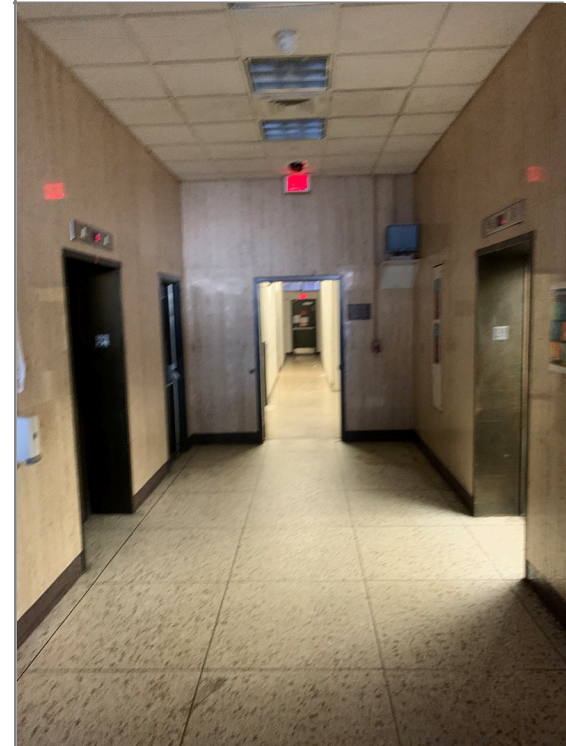
First floor elevator lobby. In general, the elevator lobby on each floor will need to be enclosed with fire rated assemblies.

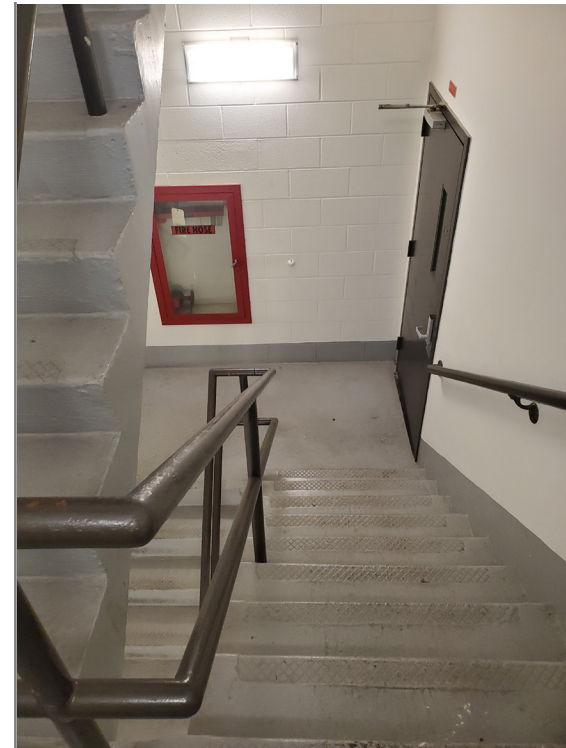
Typical egress stair with standpipe. The existing vertical enclosure meets the 2 hr fire rating requirement. Handrails and guardrails need to be upgraded to meet current codes.

Newly installed and replacement handrails and guardrails shall comply with Sections 1011.11, 1012.8, 1014, and 1015 of the building subcode, respectively.

Where 50 percent or more of a handrail or guardrail on a flight or on a level is replaced, then this shall be considered a complete replacement and shall comply with the above referenced sections. The repair or replacement of less than 50 percent of a handrail or guardrail shall be permitted to match the existing handrail or guardrail. (Building)

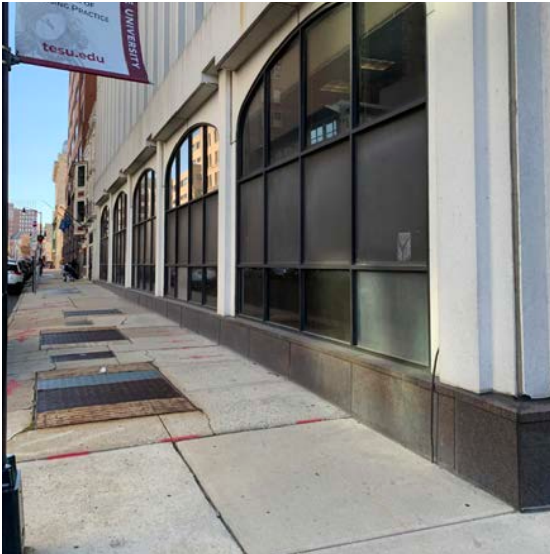
Photograph 2: North side, along West State Street. Concrete sidewalks with grates for below grade transformers.

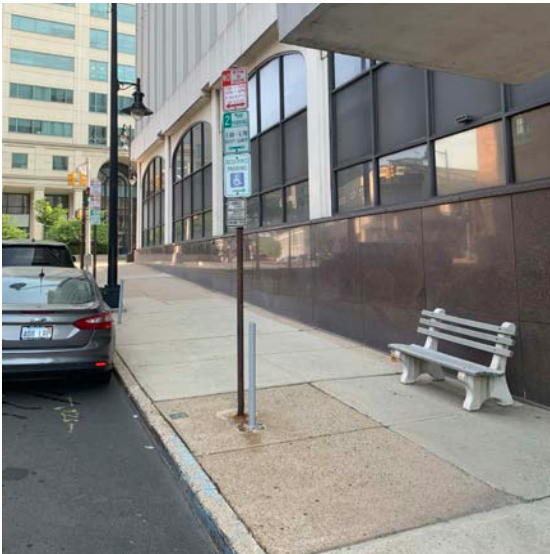
Photograph 3: West side along Barrack Street. The street is particularly wide in this area, allowing for a wider sidewalk and street trees, etc.

trees on this side of the site. Adding appropriate trees would improve the pedestrian experience. It should also be noted that the cartway for Barrack Street is particularly wide, providing an opportunity to widen the sidewalk along the west side of the building, making for a more comfortable and attractive pedestrian area and more space for plantings. See photo 3 below.

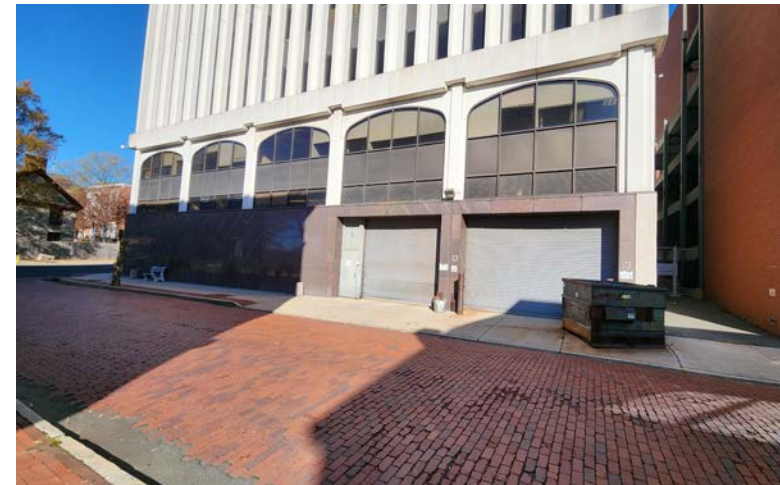
Photograph 4: South side of the building. Brick streets in this area need repair. Street trees area missing.

Front Street is largely paved with brick, which is attractive but has been patched with asphalt in a number of areas. Returning the original brick in these areas would improve the appearance tremendously. There are two empty tree pits along the Front Street side of the site which should be expanded and replanted.

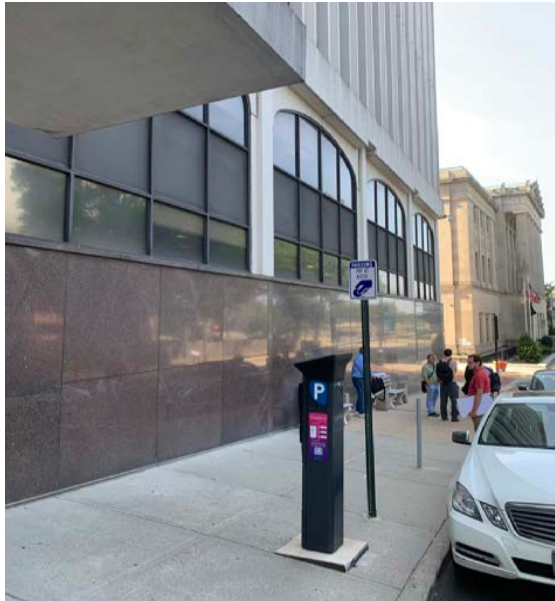
Photograph 5: West side of the building along Barrack Street with some metered parking.

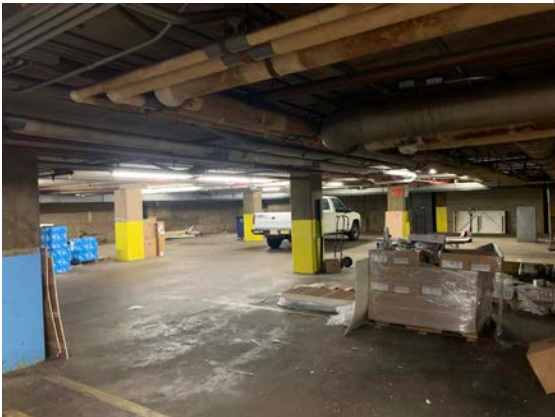
Photograph 6: Parking at the lower level of the building.

**On-site parking:** The former New Jersey Taxation Building includes 233,370 sf of occupiable space along with a basement level of about 23,600 sf. This basement level includes mechanical and storage space, as well as room for 38 to 39 cars, plus space for motorcycles and bicycles. This on-site parking area is an important resource and amenity for the building and site. As previously stated, this is likely not enough parking to fully accommodate the desired parking. This on-site amenity can be managed in several ways. For example, spaces dedicated 24/7 to residential users can be provided at a premium cost. Or, some spaces can be reserved for office users during the day and available for residential users overnight, provided to both for a monthly fee.

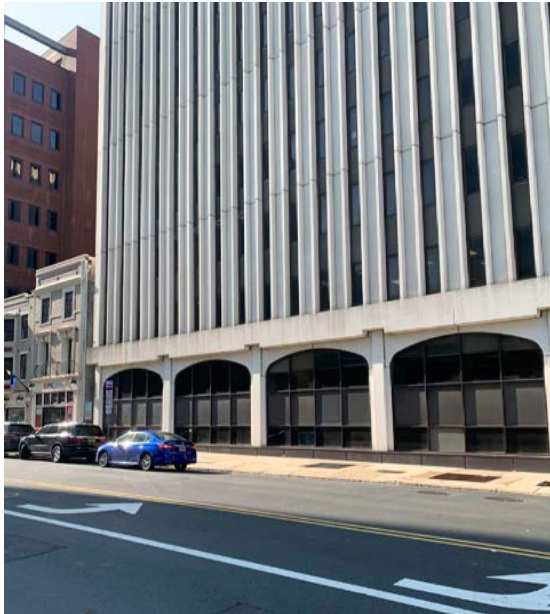
Photograph 7: There is also some metered parking, as well as a bus stop, on the West State Street side of the building.

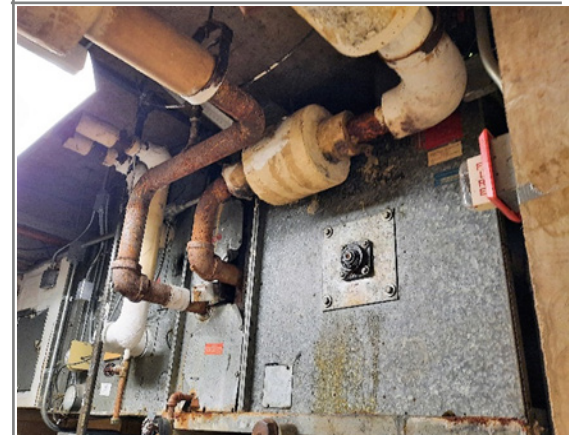
Fig. H-1 - Typical Air Handling Units

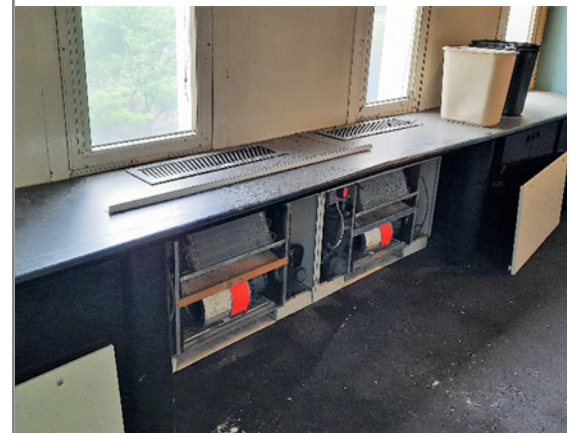
Fig. H-2 - Typical Fan Coil Units

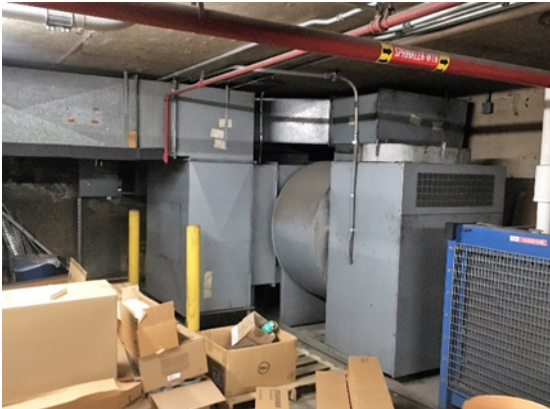
Fig H-3- Garage Exhaust Fans

centrally located adjacent to each of the 2 mechanical rooms on every floor. Ventilation/relief air is provided to the air handlers in each mechanical room from these shafts. There are 2 bathroom exhaust fans (Fig. H-9) located on the roof which are ducted down to 2 centrally located risers to each floors bathrooms. 2 stairway pressurization fans (Fig. H-10) are located atop of the 2 stairwells. Parking garage exhaust is provided by 2 garage exhaust fans and associated makeup air is provided by 1 heating & ventilating unit, all located in the garage level ducted to louvers at the exterior wall.

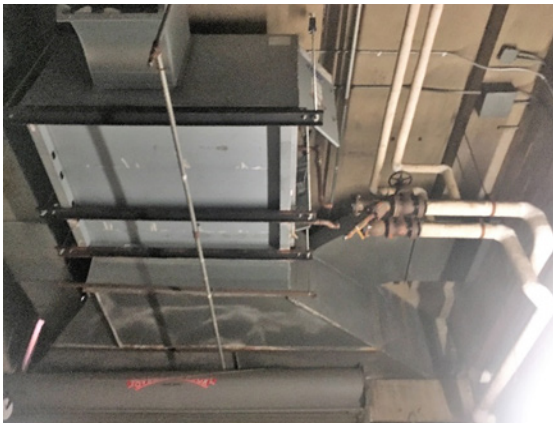
Fig H-4 - Garage Heating & Ventilating Unit

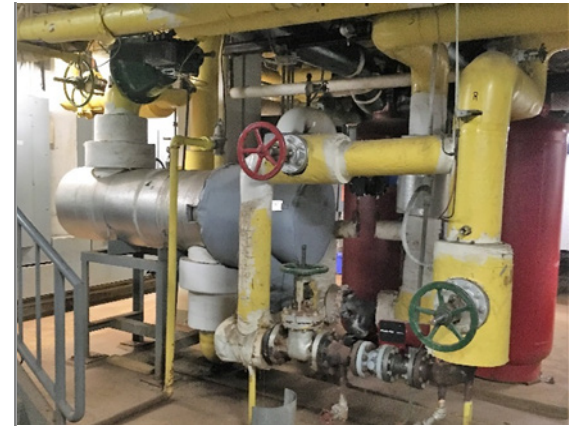
Fig H-5 - Hot Water Heat Exchanger

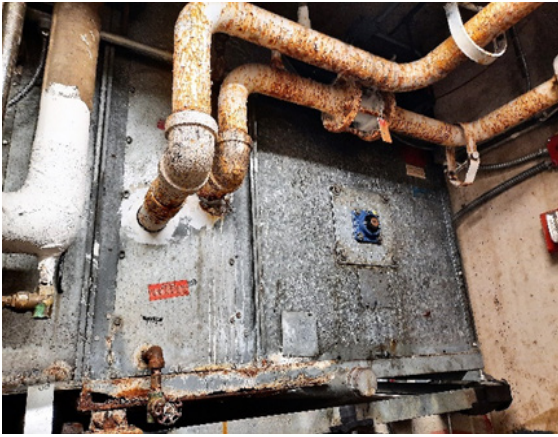
Fig H-13 - Air Handling Unit Corrosion

**General:** The air handling units, fan coil units, and piping throughout the building should be replaced. Potential changes to the HVAC systems must be integrated with any architectural changes in the programming of the building spaces. Calculated cooling loads, HVAC zoning, and ventilation should match the planned layout.

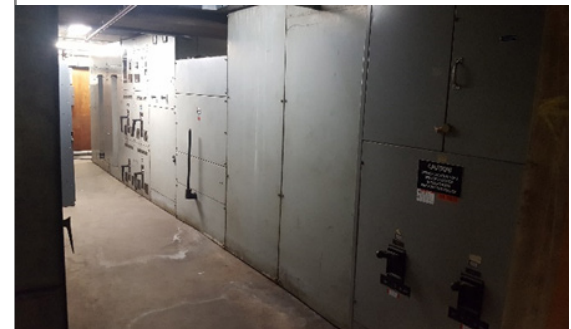
Fig E-1 Service No. 1

This service appears to have been original to the building, approximately 1967 making this equipment 56 years old.

Service No. One – The equipment appears in fair condition. It is far beyond its useful life.

Service – The equipment should be replaced in its entirety.

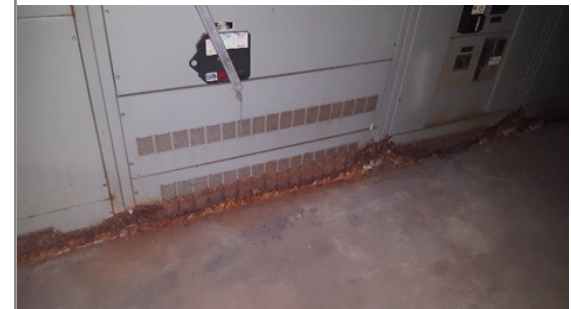
Fig E-2 - Service No. 2

Service No. Two: This switchboard is located in the garage level in the Northeast corner. It is rated for 3000 amperes (Fig. E-2). It contains the third service disconnect. This service appears to have been added to the building. This may have been part of the 1986 renovation based on the

equipment nameplate from 1985, but no documents were found confirming this. This equipment is 38 years old.

Service No. Two – The equipment appears in poor condition. The equipment was not installed on an equipment pad. The bottom of the equipment is corroded (Fig. E-2). It is far beyond its useful life.
