# FORMER TAXATION BUILDING: FEASIBILITY STUDY

MAY 1, 2024

## II. EXECUTIVE SUMMARY

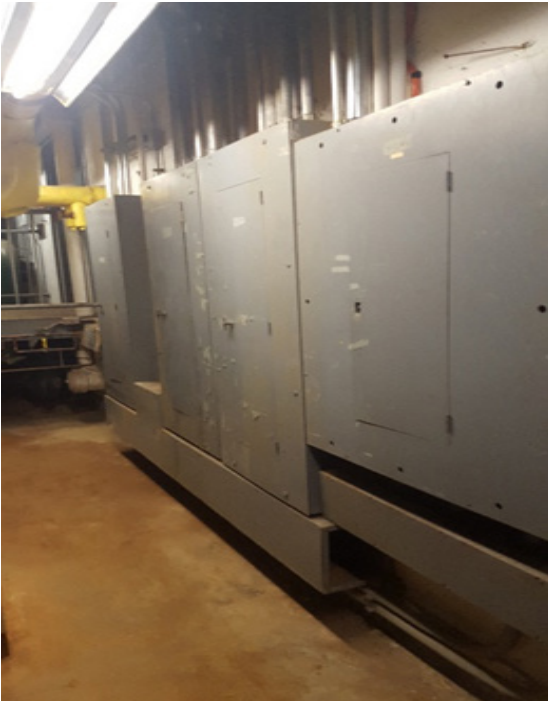
Fig E-3 - Original Boiler Room Panels

Distribution – The panels are in fair condition. Some of the circuit breakers are not identified as to the load that they serve. This is a violation of the National Electrical Code.

Distribution – The panels should be replaced and modified to suit the new of the new occupancy.

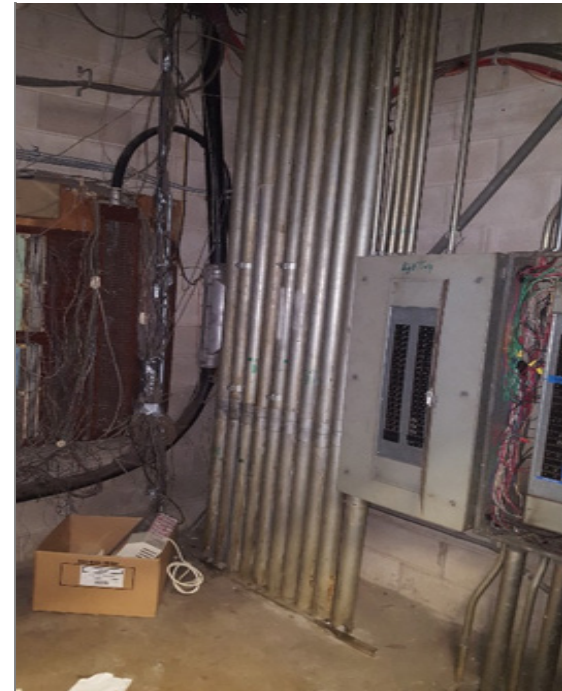
Fig E-4 - Wiring in Conduit

Wiring – The wiring is in fair condition.

Wiring – The wiring should be replaced.

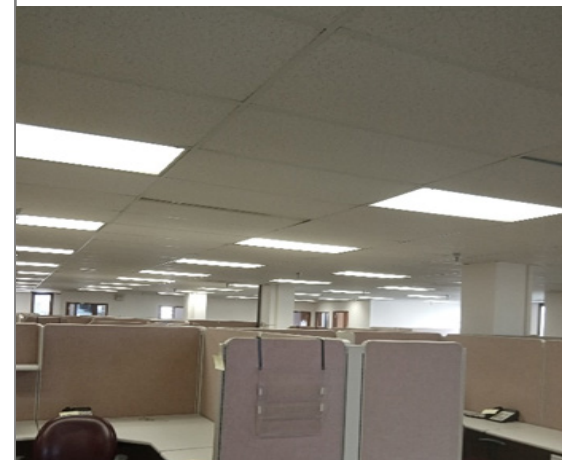
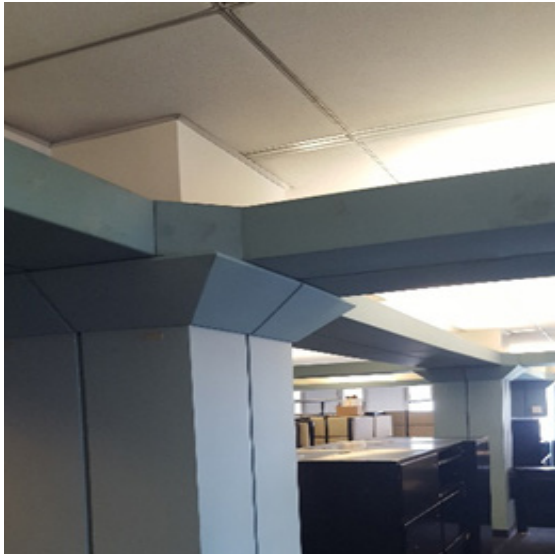
Lighting – The overall lighting system appears in fair condition. The lighting is outdated and inefficient.

Fig E-5 - Typical Lighting

Fig E-6 - Typical Lighting

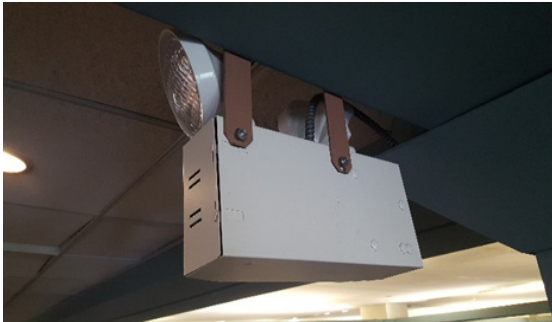
The egress and emergency, lighting system is inadequate.

Fig E-8 - Unitek Battery Light Mounted Below ADA Height

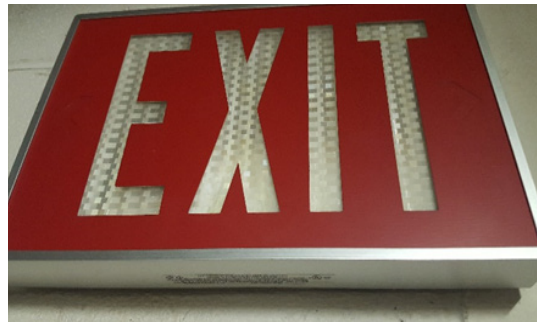
**Emergency Lighting:** Emergency egress lighting is provided in the building. The emergency lighting throughout the building appeared inadequate to meet current code. Emergency lighting consists of local, battery pack lighting, fixtures with emergency batteries in them (Fig. E-7 & 8). There is no exterior emergency lighting. There is an outdated lighting control system in the building. Exit signs illuminated by radioactive, tritium gas, were observed in the boiler room (Fig. E-9 & 10).

Fig E-9 - Exit Sign Illuminated with Radioactive Gas

The exit signs must be disposed of as directed by the manufacturer. Under NRC regulations, a general licensee using a tritium EXIT sign must:

- NOT remove the labeling or radioactive symbol or abandon the sign;
- properly dispose of an unwanted sign.
- report to the NRC or appropriate Agreement State any lost, stolen or broken sign;
- let the NRC or Agreement State know of changes to the name or address of the general licensee or the person in charge of complying with the regulations;
- NOT give away or sell the sign unless it is to remain in use at its original location; in such a case, the general licensee making the transfer must give the new owner a copy of the

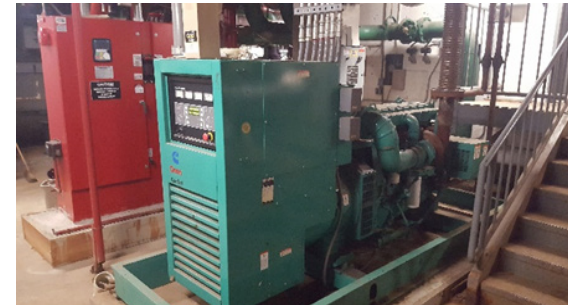
Fig E-11 - Emergency Generator

The generator status is “Shutdown” due to low frequency. The reason for the failure appears to be that the oil tank, for the generator, was cut open, the oil drained and the tank cleaned.

This removal of the oil has made this generator inoperative and the systems relying on it will not function when there is a power outage, or the fire department turns off the electric to fight a fire.

Emergency Power – The emergency generator and systems should be replaced in its entirety.

The local fire company should be notified of the current condition of the emergency system to avoid danger to fire fighters.

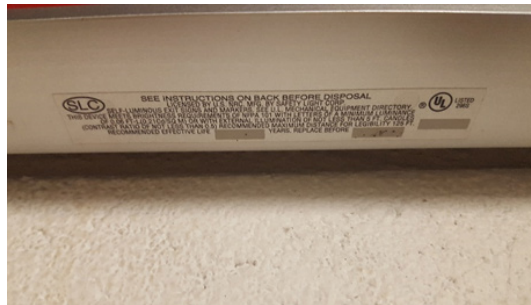
Fig E-10 - Illegible Labels on Exit Sign for Life Expectancy and Expiration Date

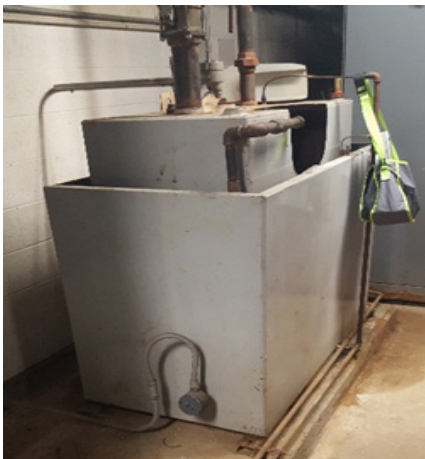
Fig E-12 - Generator Fuel Tank Cut Open and Drained

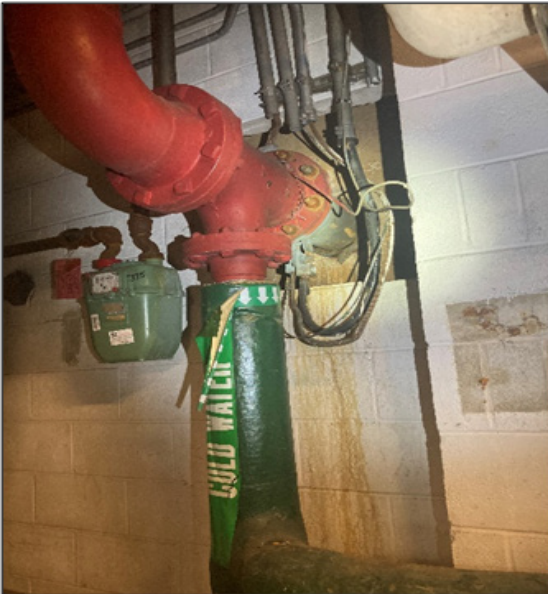
Fig P-1 - Combined Fire Protection and Domestic Water Services

Fire Protection: There is a 6" fire protection service that is combined with the domestic water service. (Fig. P-1). There is a DCDA backflow prevention device at the ceiling level (Fig. P-30). The fire sprinkler service has a 75 HP fire pump manufactured by Peerless Pump (Fig. P-31), a jockey pump (Fig. P-32) and fire pump controller manufactured by Tornatech with product # GPP-208/75/3/60 and transfer switch with product # GPU-208/75/3/60 (Fig. P-33). The system is a wet system with steel piping that serves all the floors in the building. There is a standpipe in both the north and south stairwells with dual 2-1/2" hose connections (Fig. P-34). There is a wet floor control valve in one of the two stairwells on each floor (Fig. P-35). On Barrack-street there is a sprinkler fire department connection and a standpipe fire department connection.

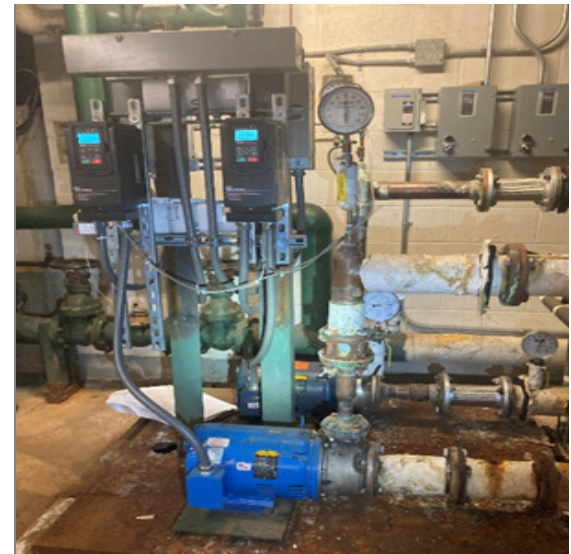
Fig P-2 - Domestic Water Dual Booster Pump System

The dual booster pump motors are approximately 9 years old and appear in good condition. The booster pump control panel appears relatively new but a date could not be confirmed.

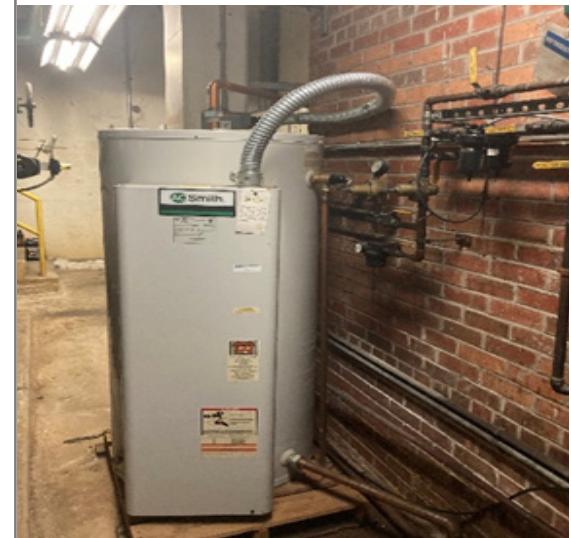
Fig P-3 Electric Water Heater

The water heater is approximately 12 years old and appears in fair condition. The water heater is resting on a wooden pallet. The water heater was not provided with an expansion tank.

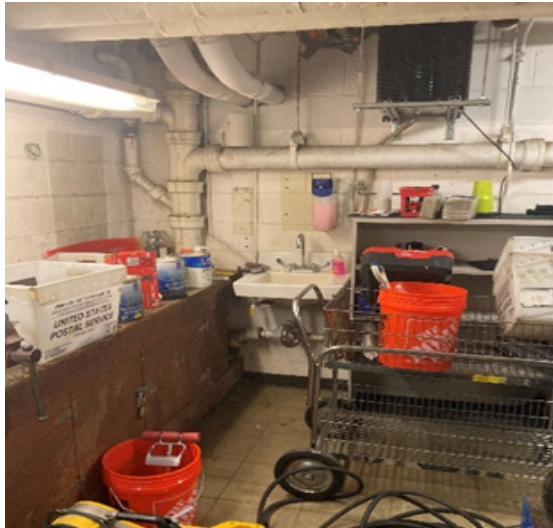
Fig P-4 - Sanitary Stack in Basement

**Sanitary:** The sanitary piping system is in fair condition. There are risers in the two mechanical rooms (Fig. P-37) serving the adjacent restrooms. There are risers behind the utility sink in the janitor's closet. The cast iron piping seems old, rusted and stained and the vent piping is galvanized steel. The fixtures are drained by gravity from the upper floors to the office room in the basement. The sanitary piping terminates under the slab in this room (Fig. P-4) and connects to the street sewer. The sanitary and storm piping may combine but was unable to be confirmed.

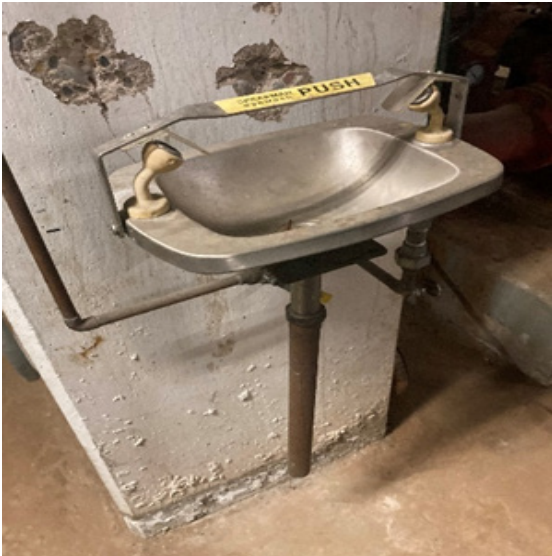
Fig P-6 - Eyewash Station

Mechanical Room (basement): The only fixture in the mechanical room is an eye wash station (Fig. P-6).

**Mechanical Room (basement):** The eye wash station appears in poor condition (Fig. P-6). The bowl seems rusted. The unit appears old and neglected.

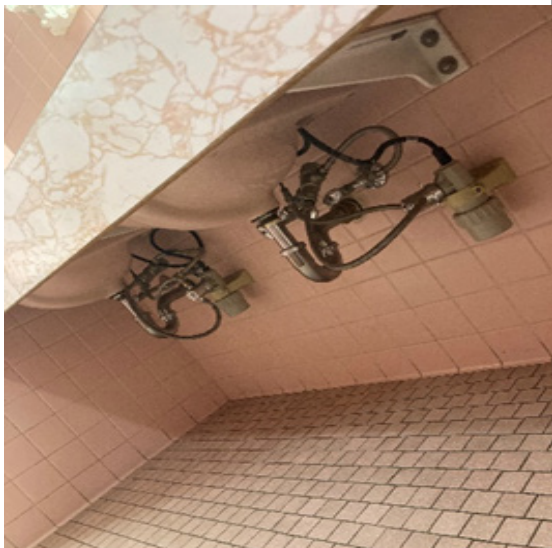
Fig P-13 - Lavatory Drain Assembly

**Women's Restroom (Fig. P-13):** The mixing valve, supply lines and power adapter are typical restroom assemblies and are old and outdated. Some of the lavatories had missing or rusted supports which was typical for the lavatories (Fig. P-17).

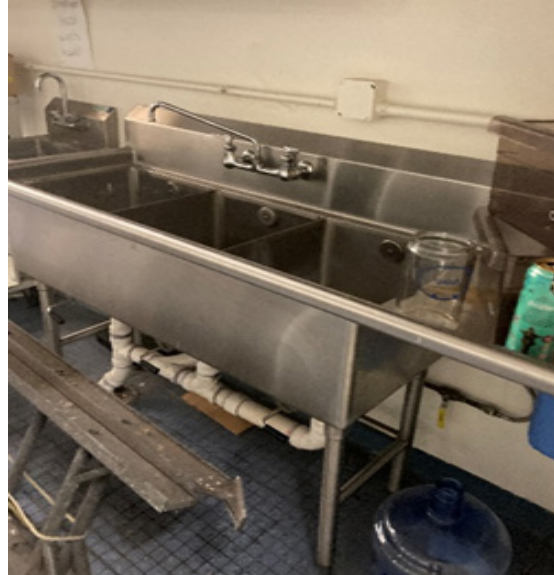
Fig P-15 Three Compartment Sink

**Cafeteria (1st floor):** The three-compartment sink (Fig. P-15) and hand sink (Fig. P-16) appear in good condition There is some discoloration but generally the fixtures and drains appear in good condition.

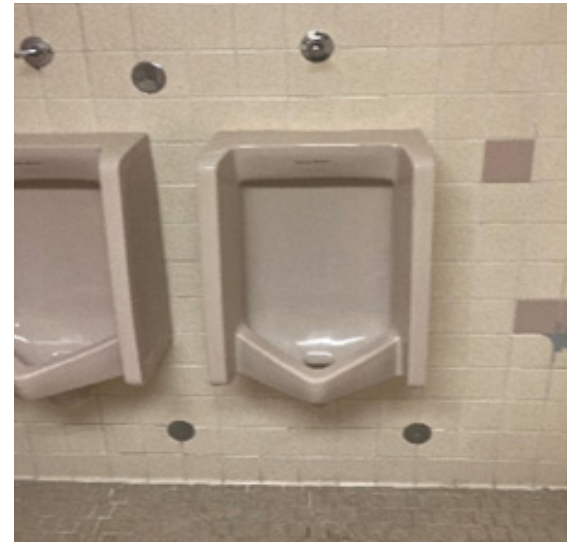
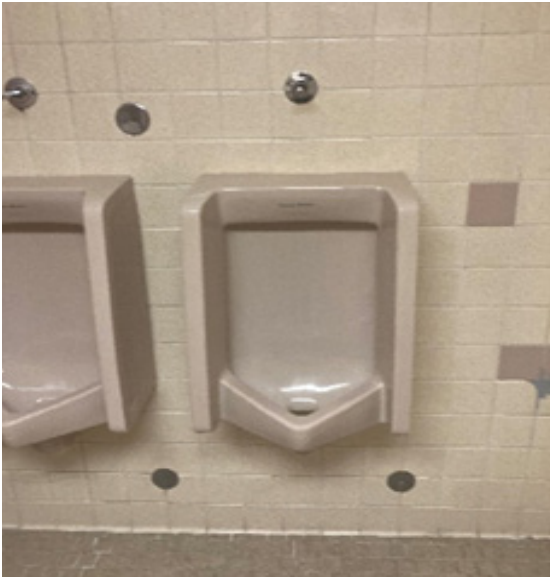
Fig P-19 - Urinals

**Men's Restroom (2nd floor):** The urinals are generally in fair condition (Fig. P-19). In some of the men's toilet rooms there is a missing urinal. It's possible the fixture support failed and the fixture was removed. The lavatory faucets are the same in the men's and women's toilet rooms and appear in poor condition. They appear old, rusted and many of them didn't work most likely due to old batteries.

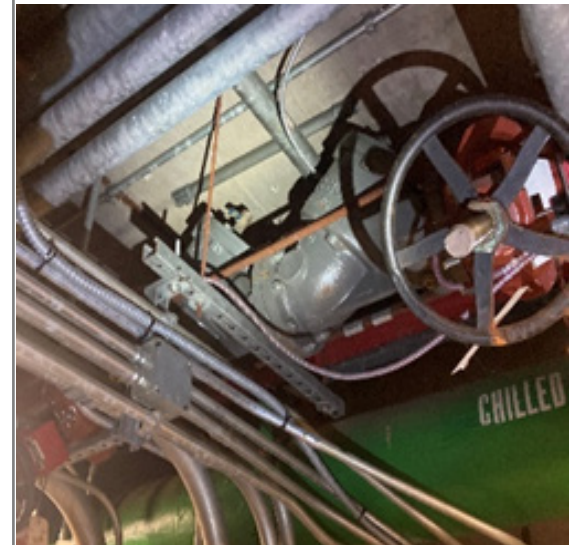
Fig P-30 - Fire Protection Backflow Preventer

**Fire Protection:** The backflow preventer in the basement is at the ceiling level which is not code compliant (Fig. P-30). The unit is required to be in an accessible location.

**Fire Protection:** The fire pump should be tested by a licensed plumber and should be replaced if over 25 years old. The fire pump motor should be replaced in approximately 7 years. The fire pump is required to have stand-by power (see electrical report). The sprinklers should be inspected and replaced as required. The sprinklers on floors with blackened ceilings should be replaced. The DCDA backflow device should be accessible. Current code requirements are to be located a minimum of 5'-0" above finished floor. This may need to be relocated upon future renovations.

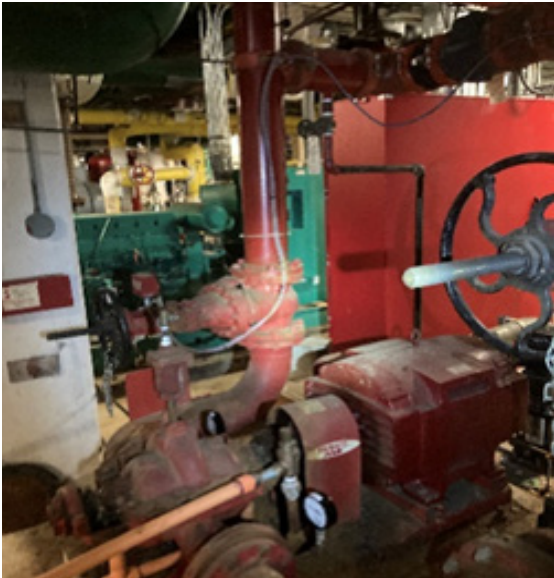
Fig P-31 - Fire Pump

The horizontal split case fire pump (Fig. P-31) appears in poor to fair condition with rust and corrosion on the housing. The age was not able to be confirmed. The fire pump motor appears in fair condition and was manufactured in 2015. The fire pump controller and transfer switch (Fig.

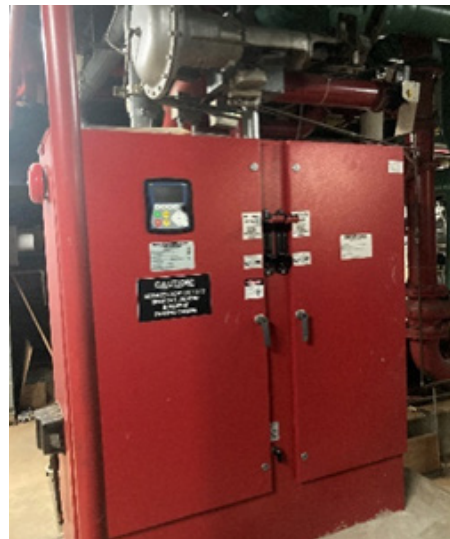
Fig P-33 - Fire Pump Controller

P-33) appear in good condition. The fire pump does not have emergency stand-by power because the generator does not have a fuel source.

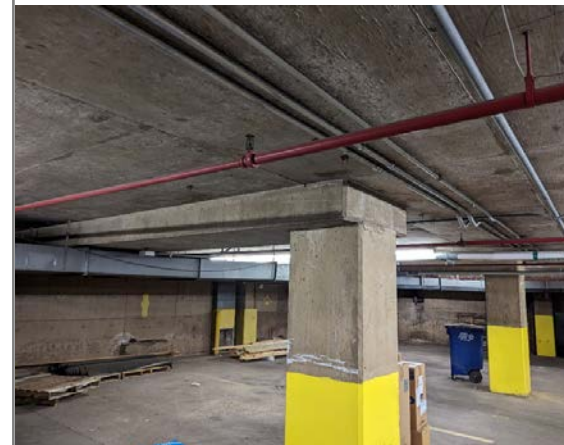
Photograph 2

1. The building is in good structural condition.
2. The building is a ten story, cast-in-place concrete structure. It is most likely that the floor and roof structures were designed as a two-way spanning flat plate. See Photograph 1. In some locations of longer spans and spandrel conditions, concrete beams were used for additional strength. See Photograph 2.

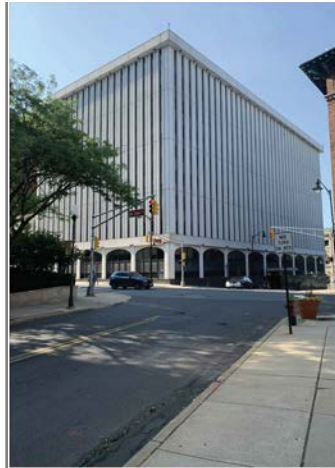
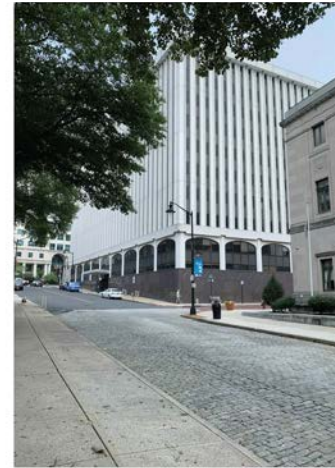
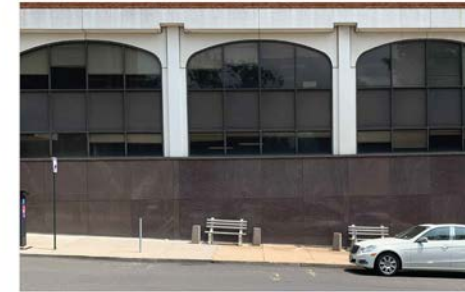
EXISTING CONDITIONS PHOTOS

The photographs and drawing at the right show the existing conditions of the exterior of the former Taxation Building. Neither the windows nor the exterior walls are insulated. There is a solid polished black granite base along the Front Street elevation and part of Barrack Street.

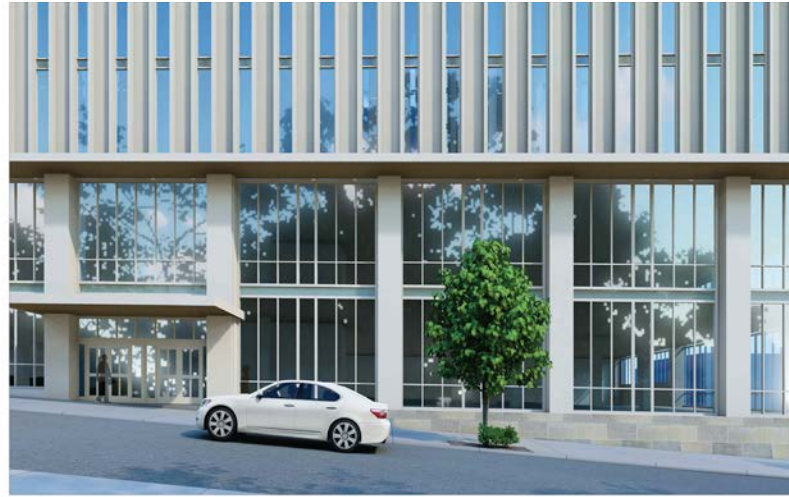
In this first option, the windows are replaced with floor to ceiling units, adding light and views to the interior. In addition, the arches and granite are removed from the ground floor. New windows and doors are added to open up and brighten the lower levels, adding vitality and interest both to the interior and exterior.

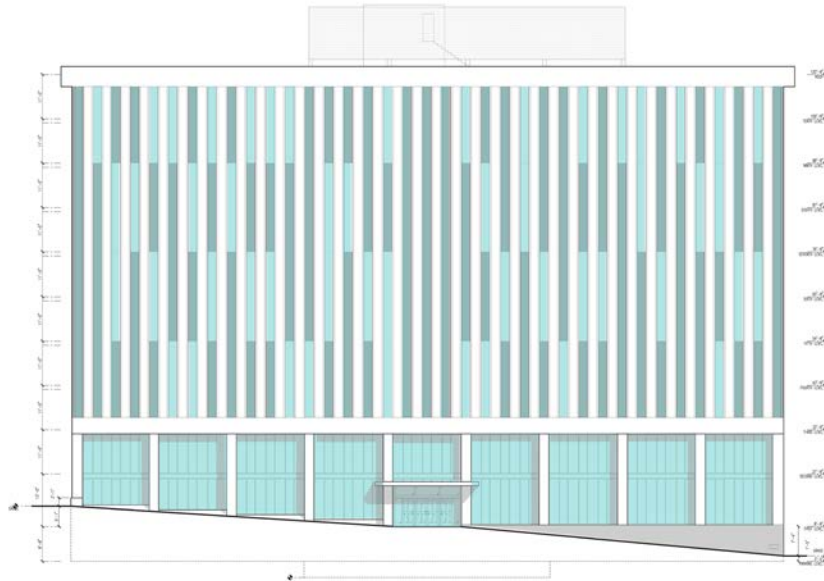
In this option, the entire facade is replaced with a glass curtain wall. The glass could be articulated with various colors of glazing, frit patterns to reduce solar heat gain, or even operable panels inset into the curtainwall system for operable windows. The lower two levels are expressed as a collonade with the glazing located behind the structural columns. Entry canopies would help identify building entrances at State and Barrack Streets.

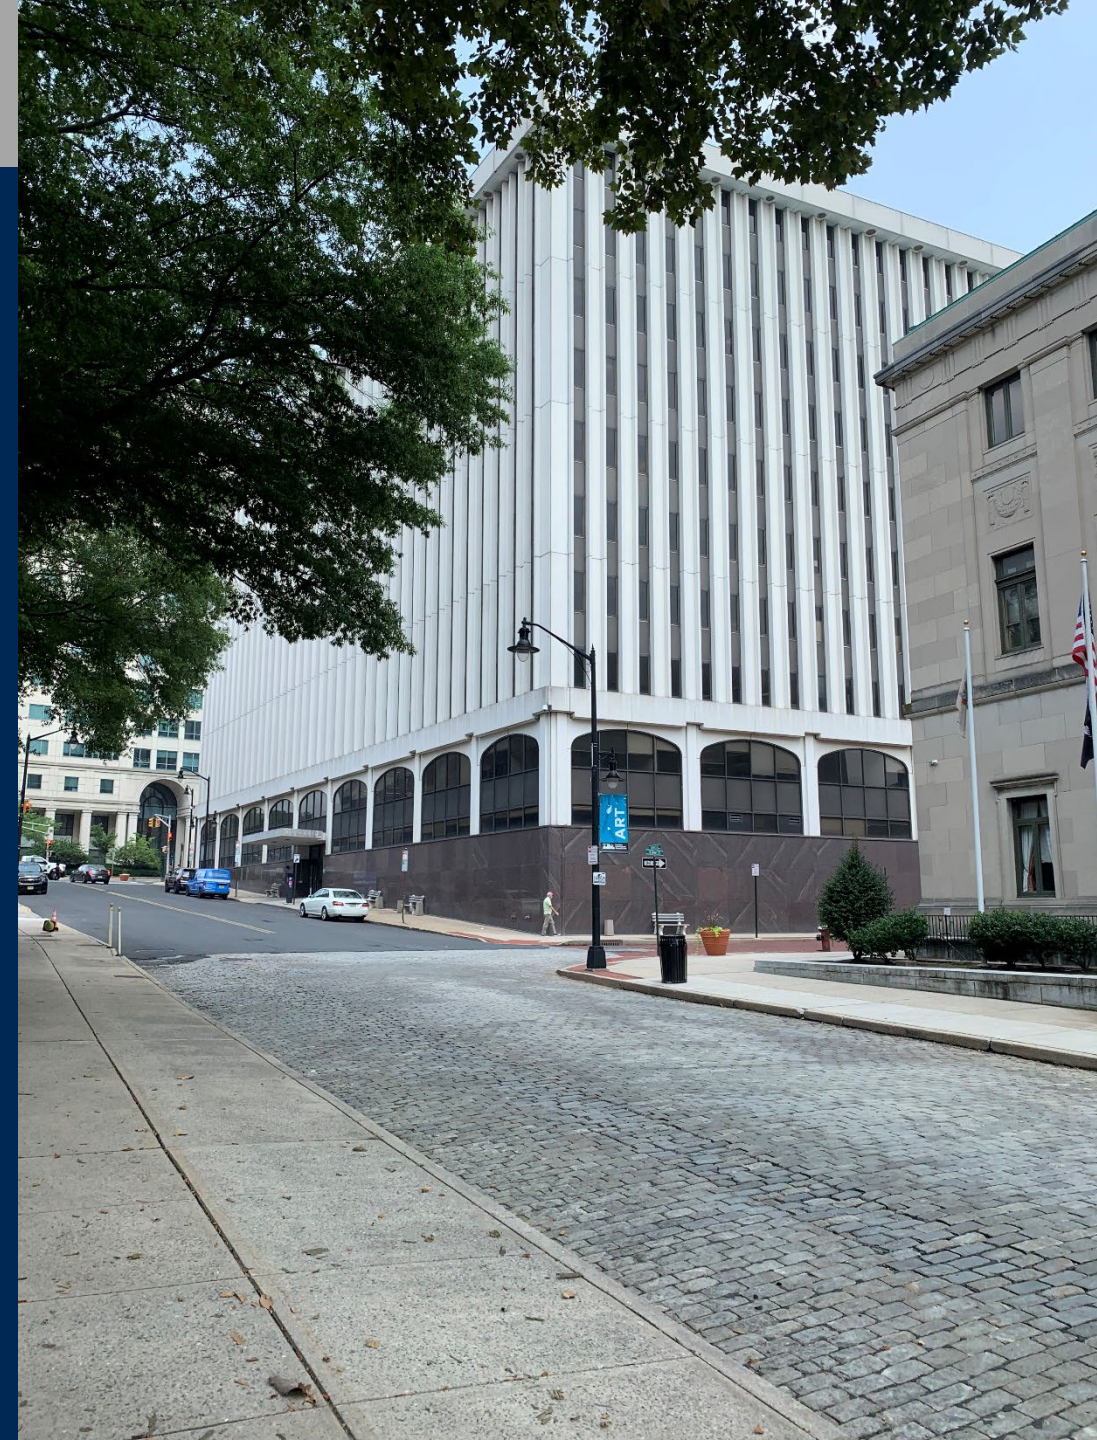
## 1C. Existing Conditions: Exterior Envelope

- Modernist Style Common at the Time of its Construction (1968).
- The Height of the Building is Similar to Several Others in Trenton's Downtown Core (Ten Stories), but the Exterior Design Gives a Monolithic Impression.
- The Lower Story Arches Attempt to Bring the Scale Down at the Sidewalks, but the Windows are Not Placed at Eye Level and the Polished Granite Rises to Give a Fortress-like Impression.
- The Building is Not Situated Within a Historic District but is Near a Number of Architecturally Sensitive and Significant Buildings.

Base Recommendations: Add Entry Along West State Street, Improve/  
Open Up Base and Replace all Windows

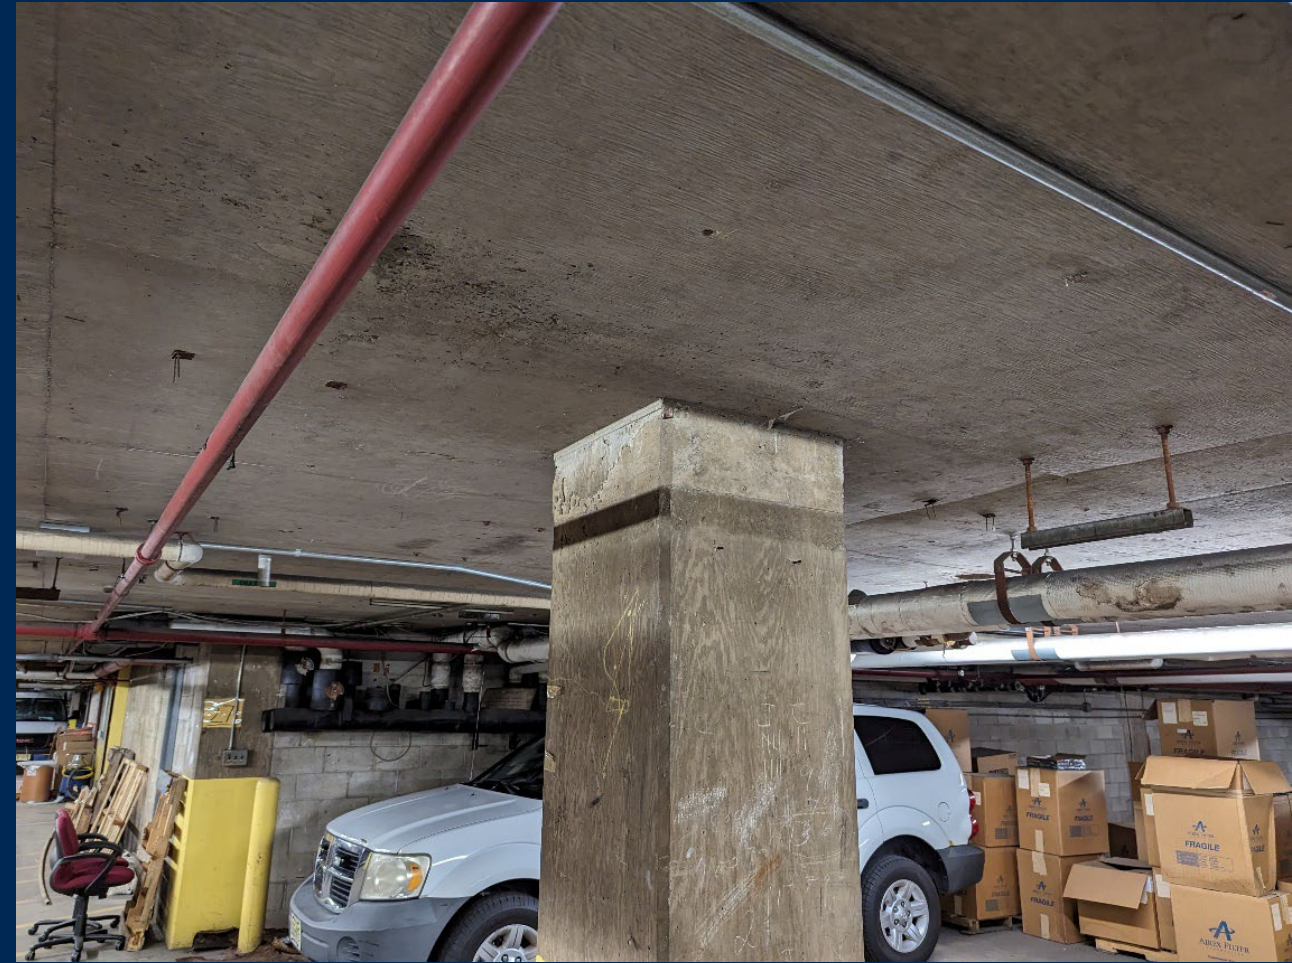
## 1F. Existing Conditions: Structural Analysis

- The building' structure is in good overall condition.
- The existing structure is cast-in-place reinforced concrete with reinforced concrete two-way floor slabs.
- The floor slabs can support a live load of 100 psf or more, adequate for all anticipated uses.
- Lateral resisting elements include the elevator and stair shafts.
- The existing concrete structure has a 2-hour fire resistance rating.
- The exterior walls are not load-bearing and can be reconfigured. Replacing the exterior walls will not compromise the structure of the building.
- In order to provide a new entry at West State Street, portions of the second floor slab may be removed to create a lobby at grade.

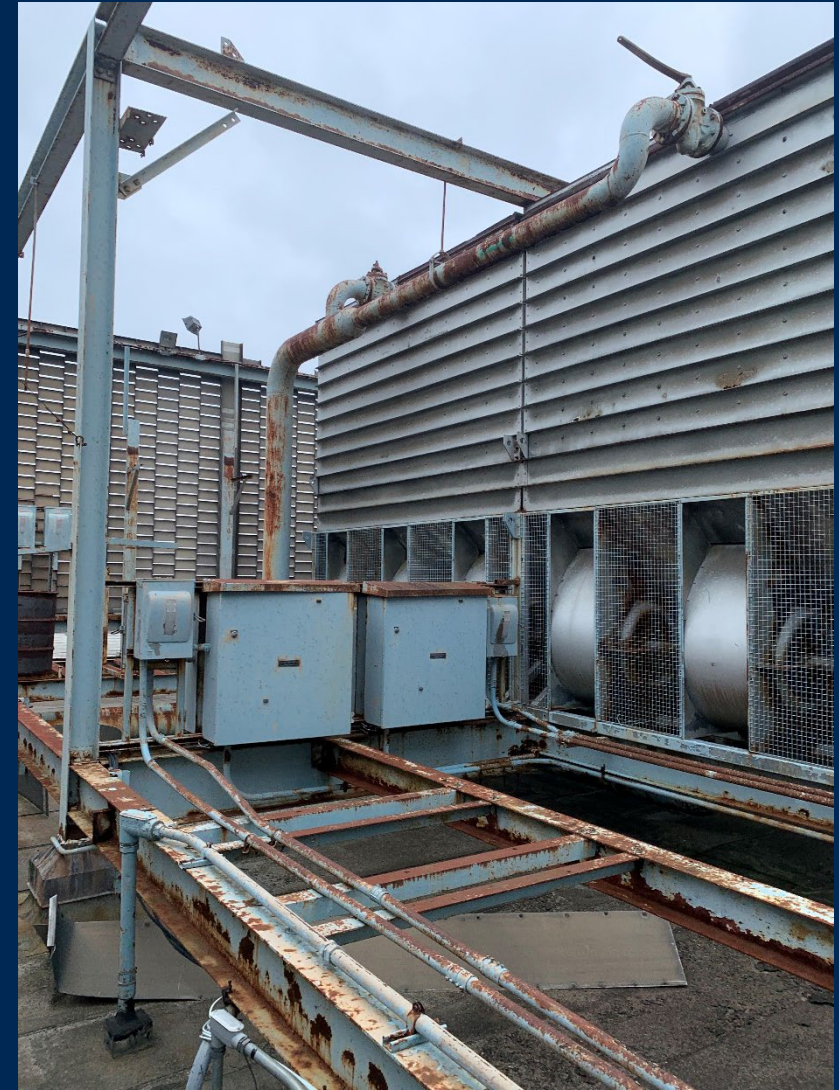
# 1G. Existing Conditions: Mechanical, Electrical, Plumbing, Fire Protection Analysis

- Four-pipe hydronic heating and cooling system with hot and chilled water risers located in the central mechanical rooms on each floor and along the uninsulated exterior walls. At floors 2-10, two interior air handling units are in the mechanical rooms. The basement has a main mechanical room with boilers, pumps and heat exchangers. The system is connected to the District hot and cold-water system.
- There are abandoned water chillers in the basement and cooling tower on the roof.
- Ventilation is provided from two shafts; the basement parking garage includes mechanical ventilation. Toilet rooms are exhausted to the roof.
- The existing controls are an outdated pneumatic system fed from a central compressor.

Base recommendation: Replace the entire HVAC system with one that's more energy efficient, responsive and appropriate for the building's new uses. A VRF system is recommended.

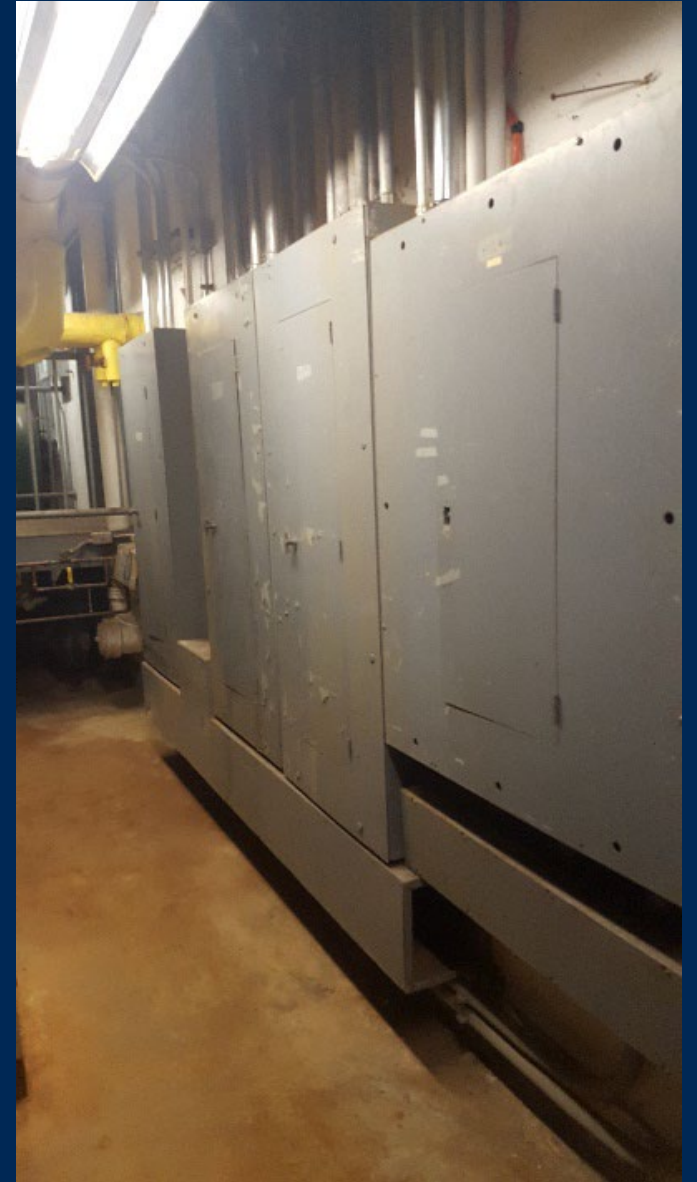
## MEP/FP ANALYSIS SUMMARY

Base Recommendation: Service is adequate for the building; switchgear, most distribution and fixtures will need to be replaced. All lighting should be LED.

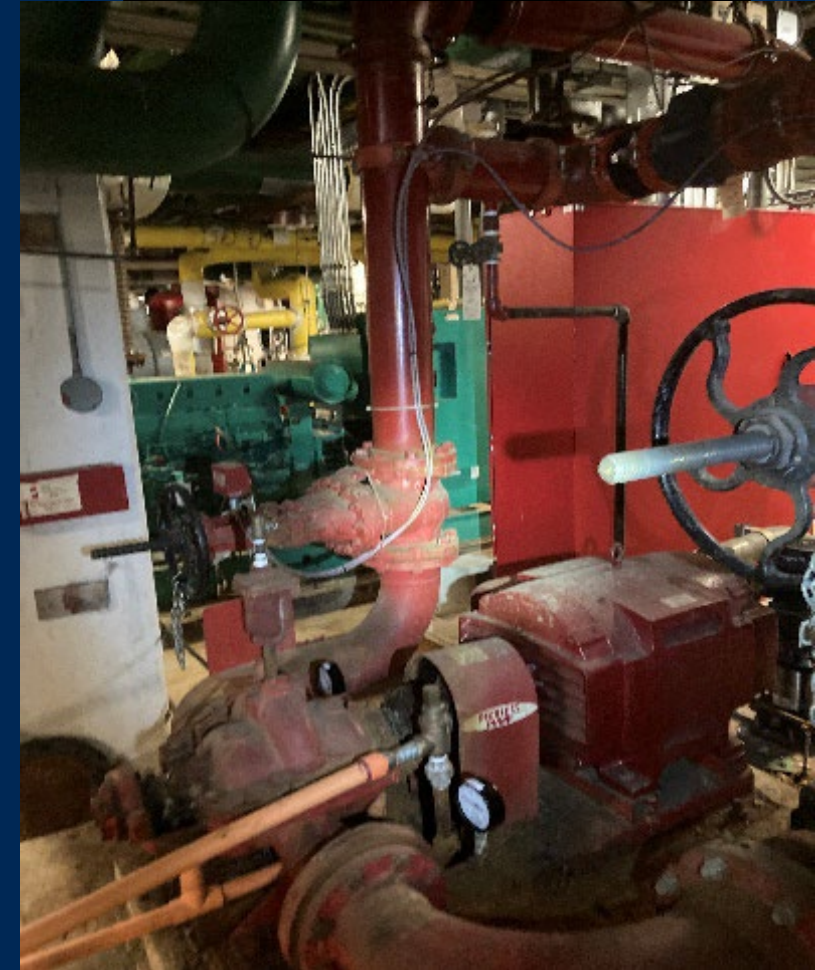
- The 6" fire protection line is combined with the water service entry.
- The backflow preventer is located at the ceiling level in the basement.
- There is a 75 HP fire pump and jockey pump for the sprinkler system.
- The north and south stairwells include standpipes with dual 2 ½" hose connections.
- At Barrack Street, there are fire department connections for the standpipes and for the sprinkler system.
- Sprinkler heads vary in the building with upright heads in the basement, concealed heads on most of the upper floors and pendant heads on the eighth floor.

Base Recommendations: Fire protection system, including the sprinkler system, will need to be reconfigured and upgraded to meet new uses and current code requirements.

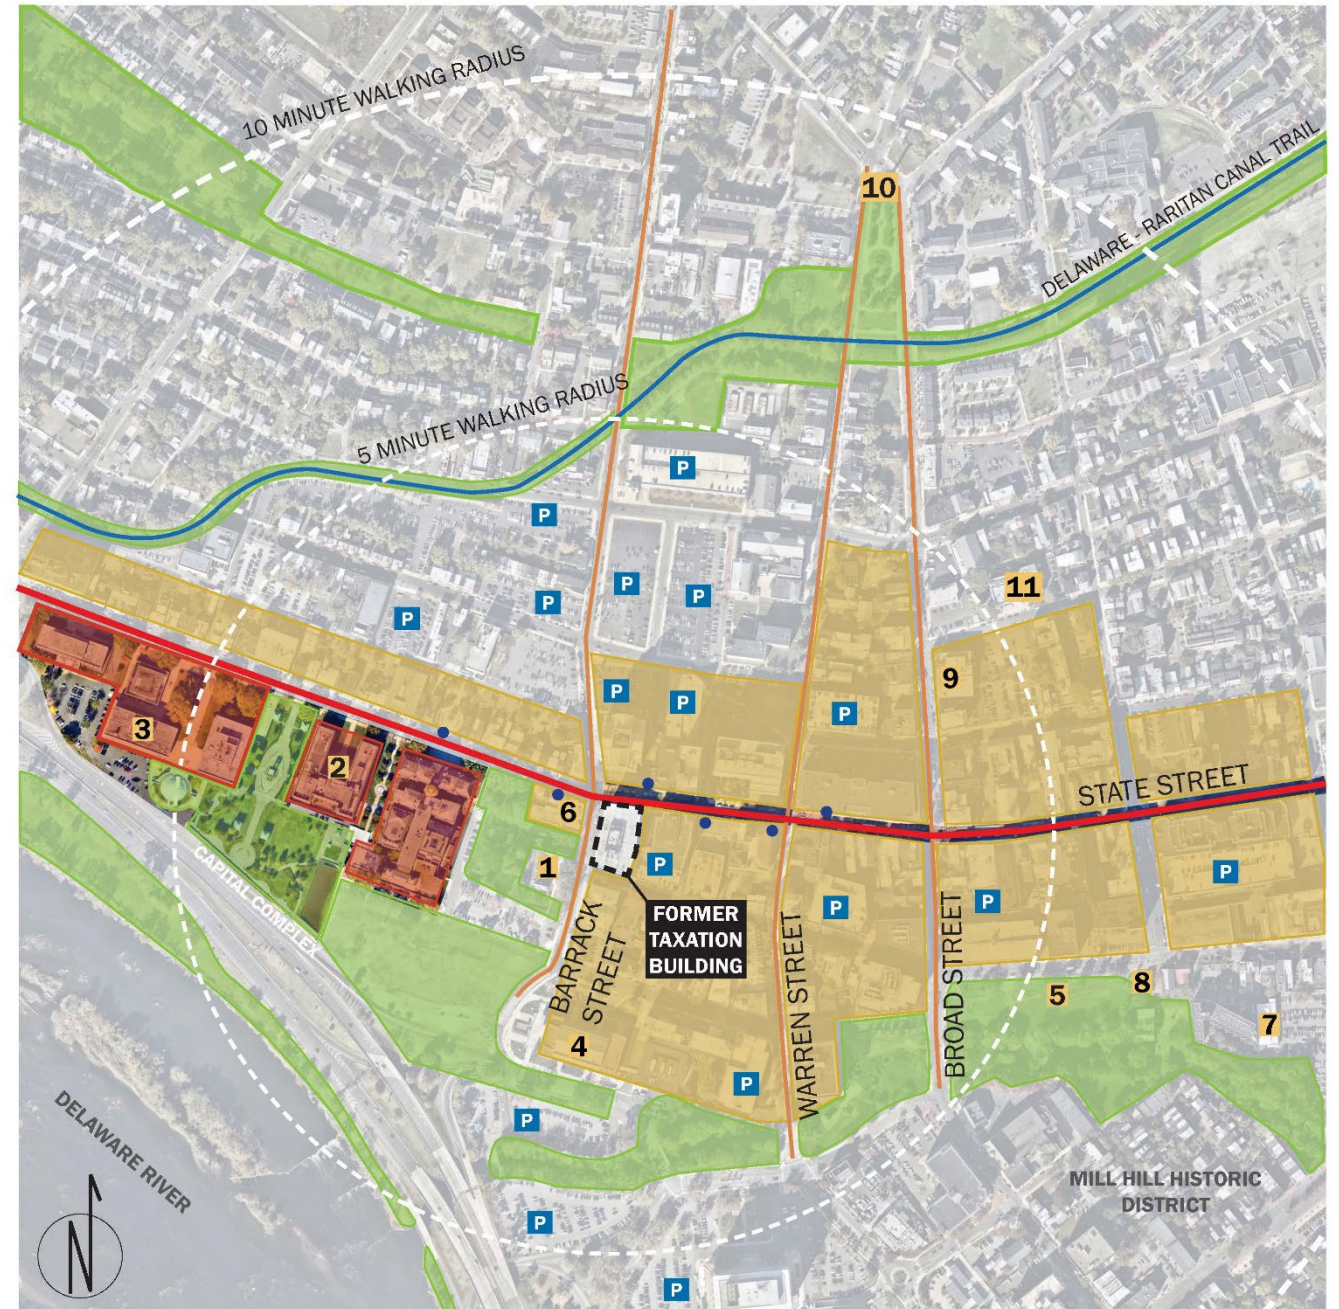
- The lower level of the building has 38 existing parking spaces accessed from Front Street. Depending on the mix of uses of the building and the number of residential units, desired parking might range from 150 to 200 or more spaces.
- There are a number of parking garages located nearby, both privately owned and owned by the Trenton Parking Authority.
- The Trenton Parking Authority has confirmed the availability of spaces, particularly in the evening and overnight.
- Additional discussions with City and TPA to occur on this topic

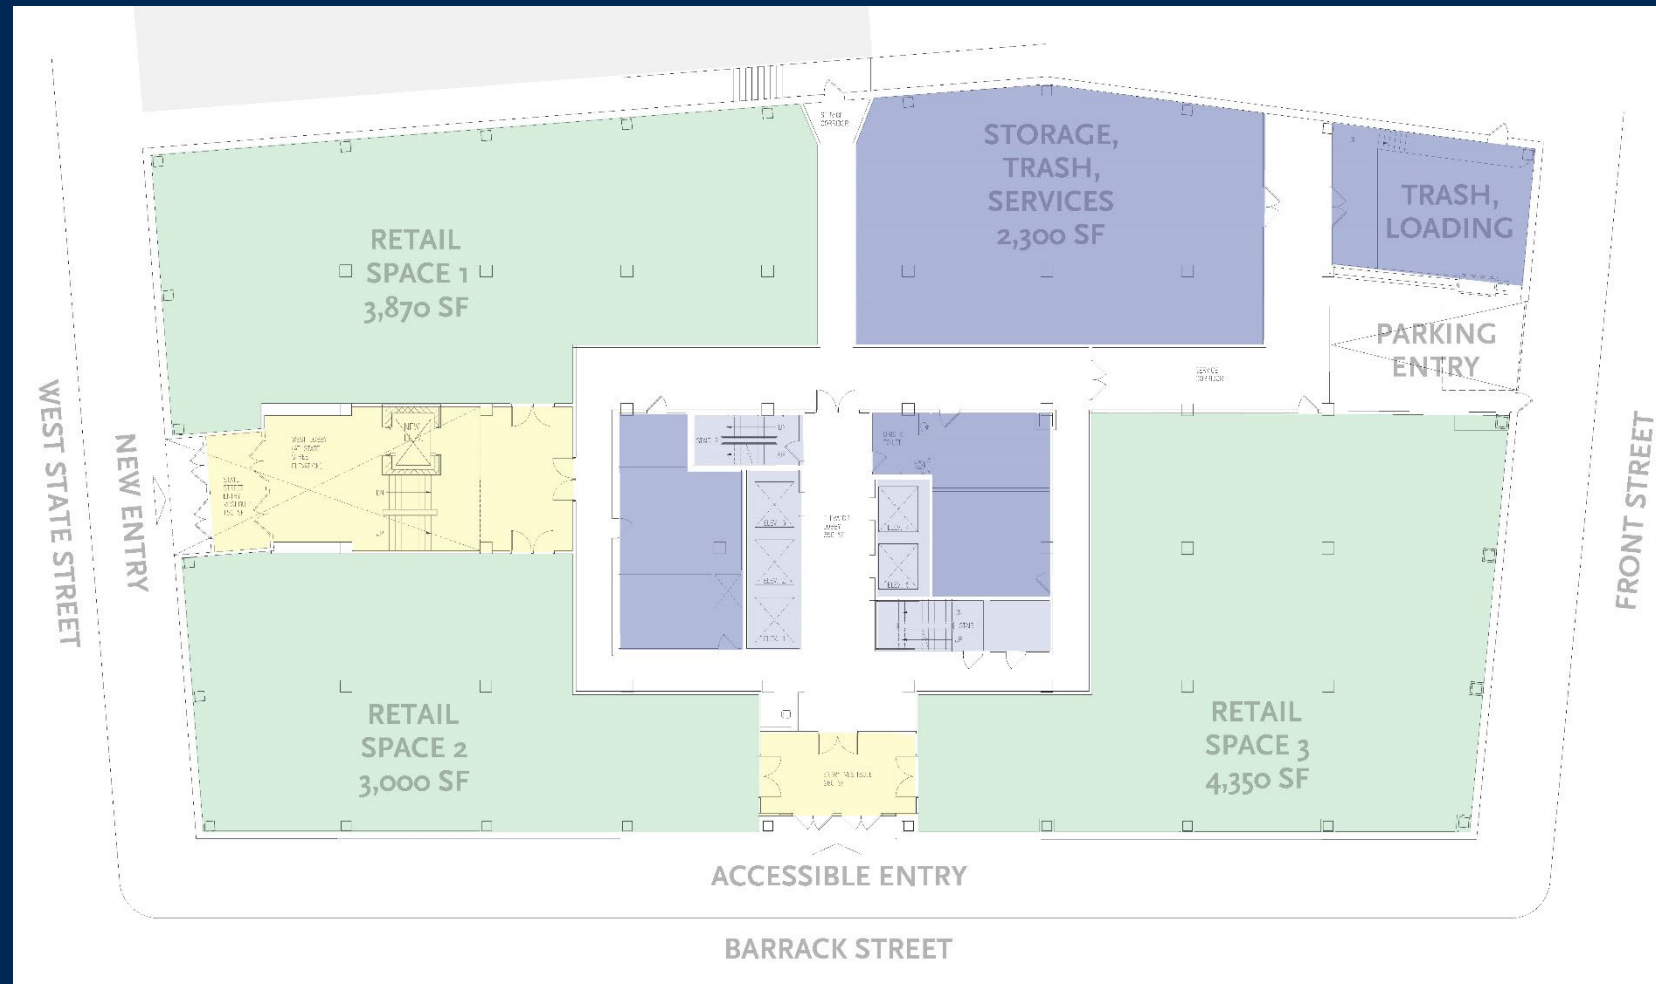
### First Floor Retail Option

- West State Street Entry Lobby
- Barrack Street Lobby
- Three Traditional Retail Tenant Areas
- Centralized Building Storage and Services
- Common Building Core Space

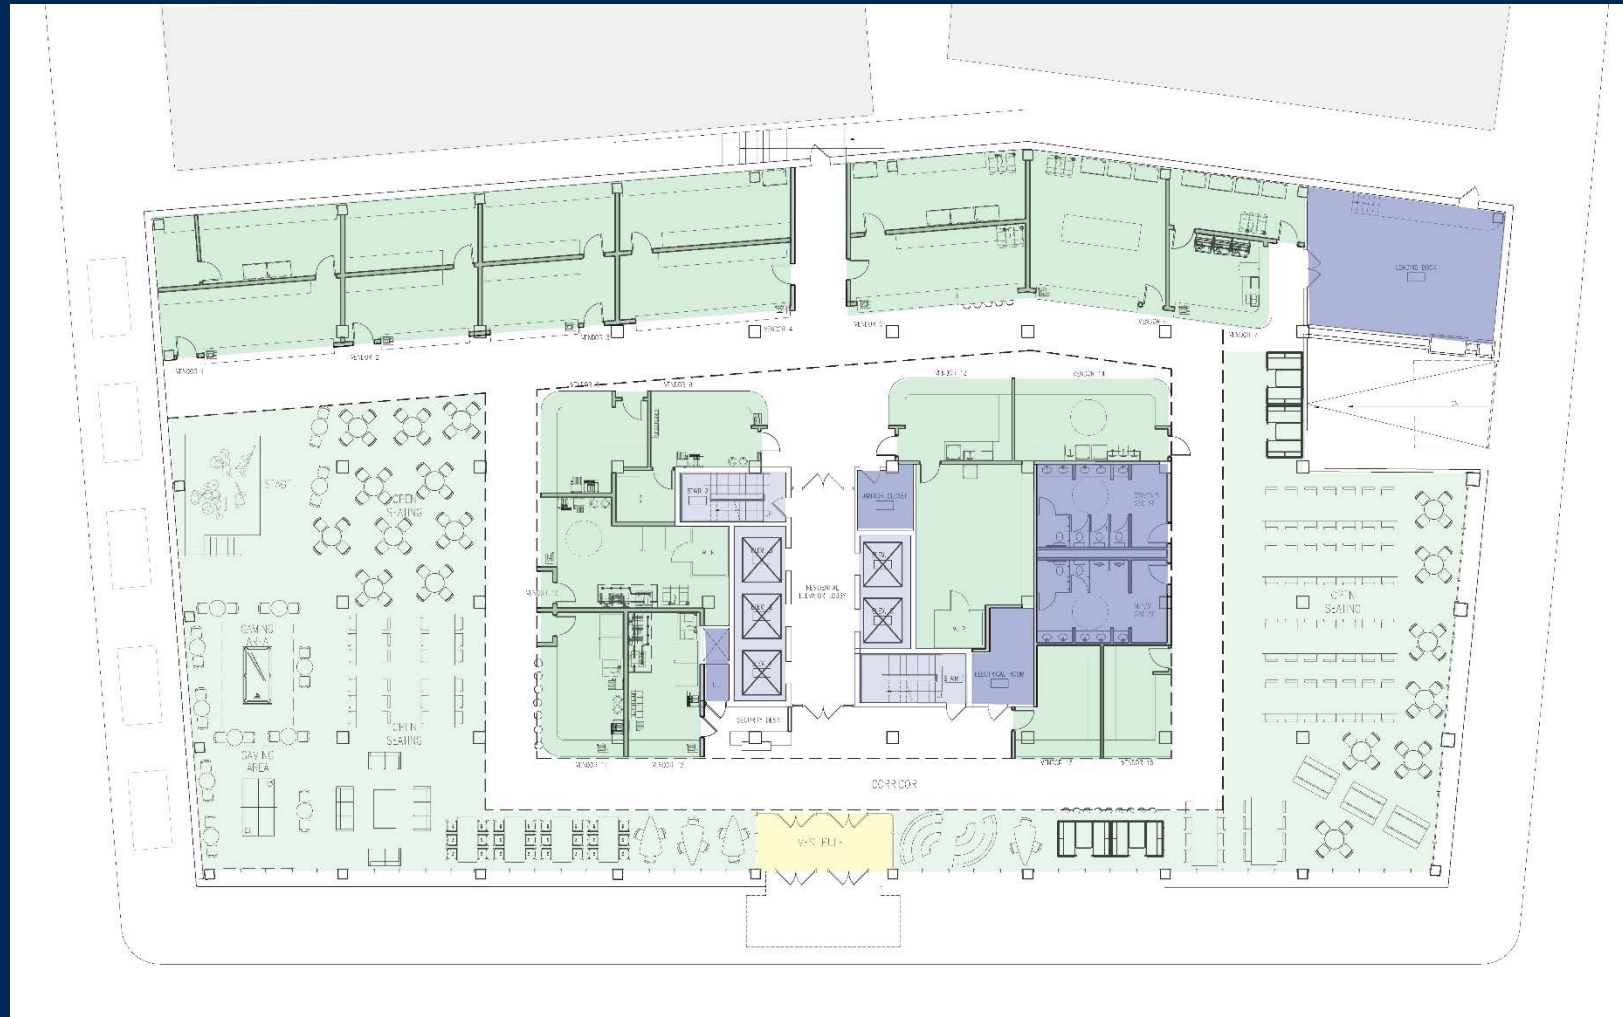
## First Floor Retail Option 2: Food Hall Concept

- Barrack Street Lobby
- 16 Food Hall Vendor Stations
- Centralized Building Storage and Services
- Common Building Core Space

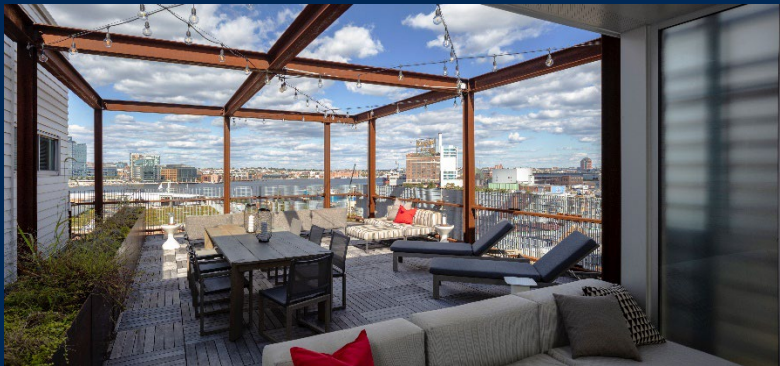
### Roof Amenity Deck: Solar + Plaza Deck + Gardens

- Additional Elevator to provide Roof Access
- Extend North Stair to Roof
- Re-use Roof Screen Structure for Solar Array
- Ballasted Solar Array at North End
- Plaza Spaces at Southern Corners (Best Views)
- Interior Amenity Room Addition
- Common Building Core Space
