# FORMER TAXATION BUILDING: FEASIBILITY STUDY

MAY 1, 2024

## II. EXECUTIVE SUMMARY

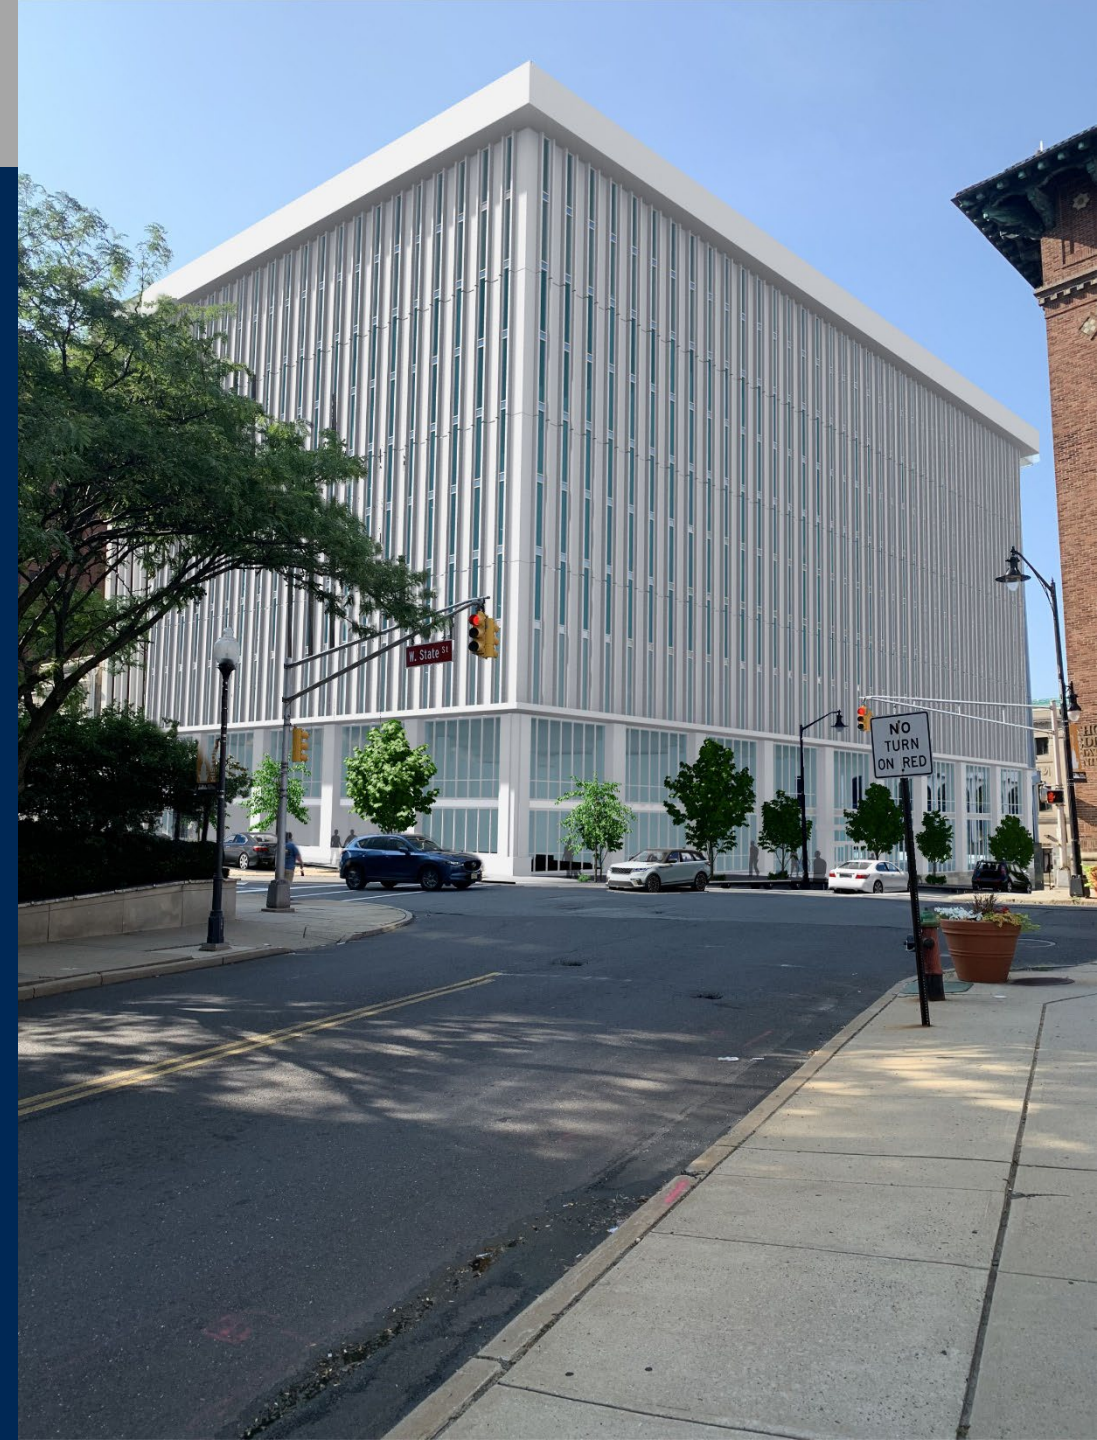
## 4A. Proposed Façade Treatment: OPTION 1

### Replace Windows Between Fins

- Maximize Glazing
- Maximize Thermal + Visual Performance

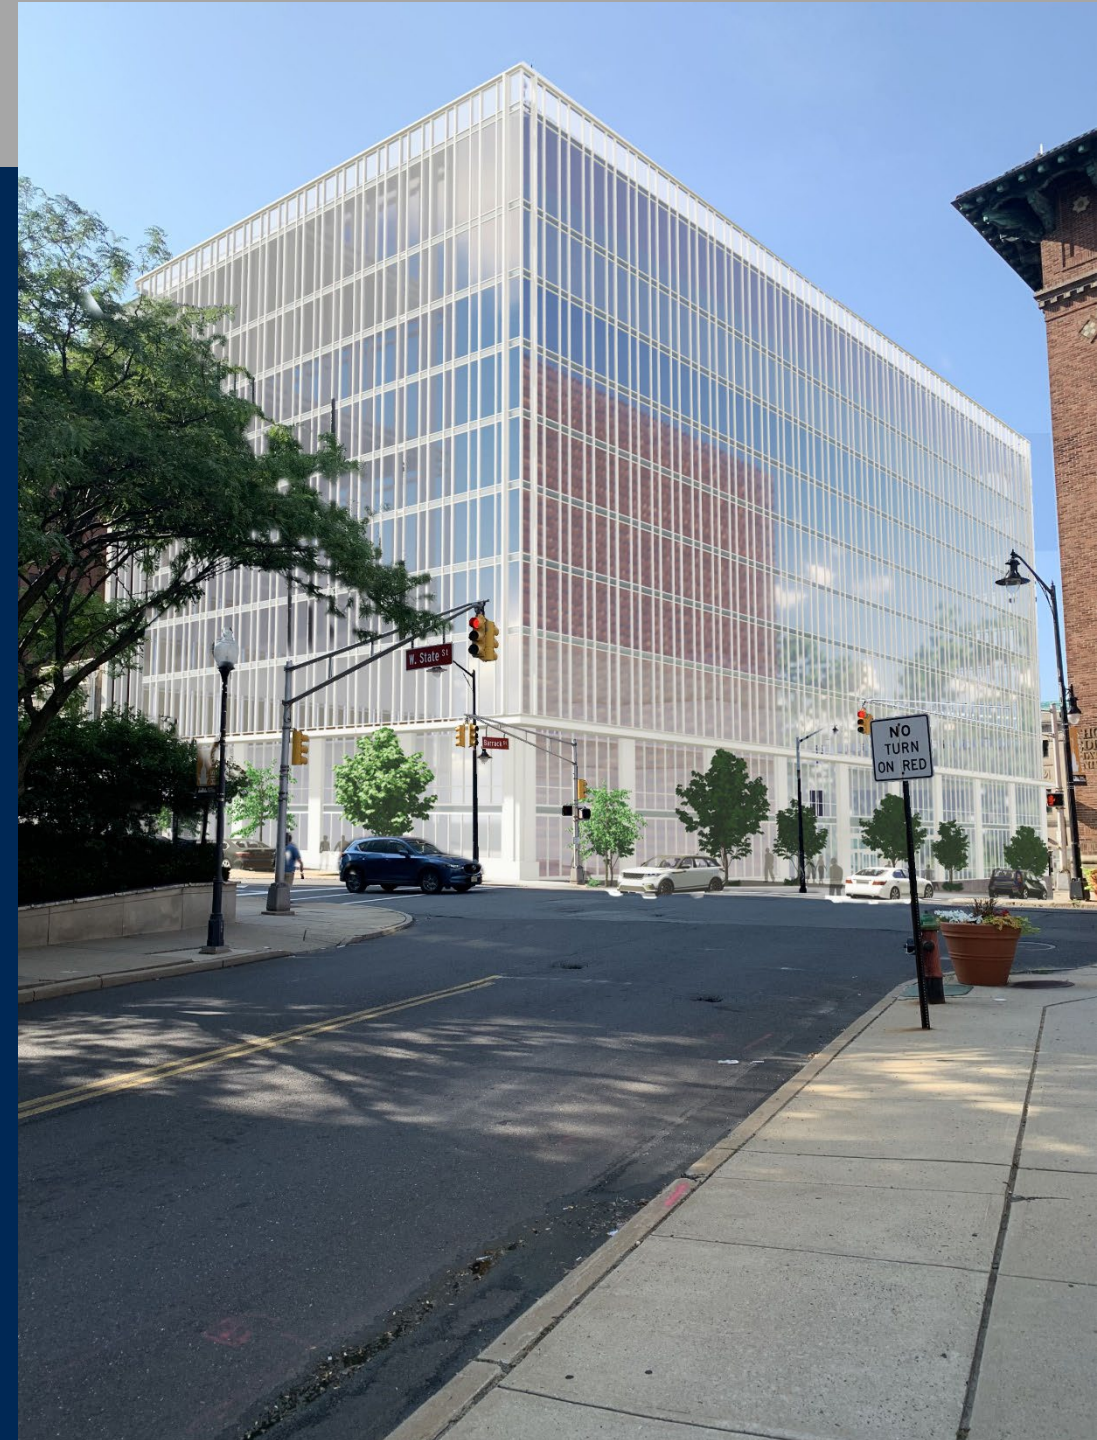
## 4B. Proposed Façade Treatment: OPTION 2

### Replace Concrete Fins at Floors 3-10

- New Thermally-Broken Curtainwall System
- Maximize Glazing
- Maximize Thermal + Visual Performance

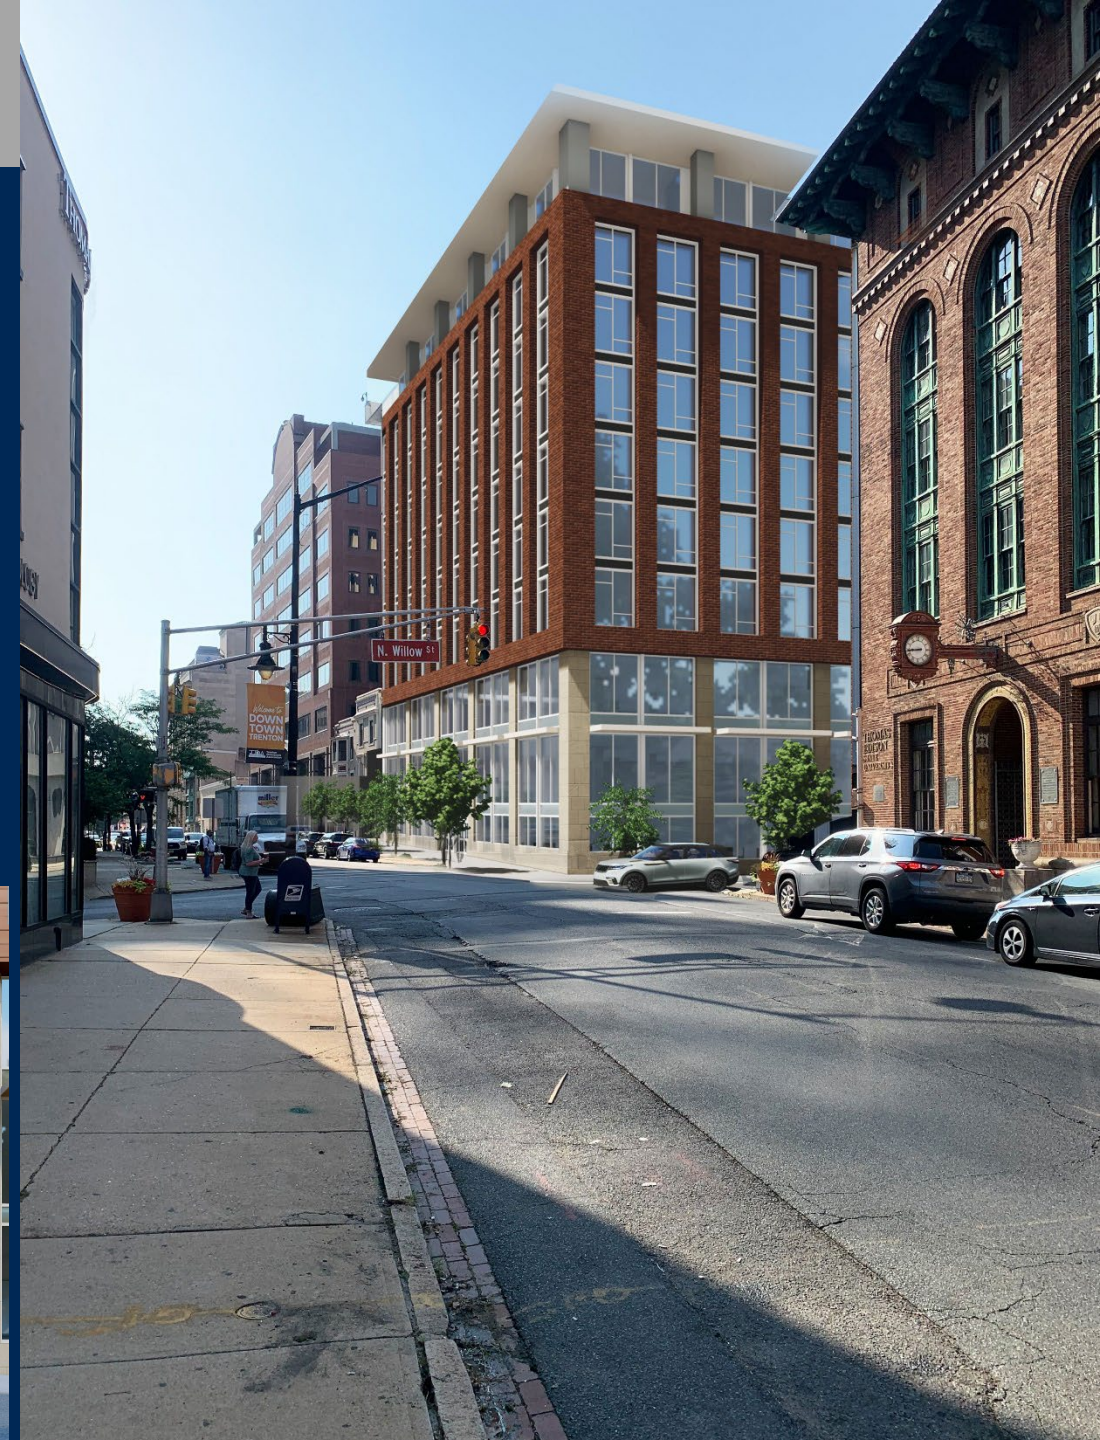
## 4C. Proposed Façade Treatment: OPTION 3

### New Façade at Floors 4-10

- Smaller-Scaled Operable Windows
- Terra Cotta Rainscreen Façade  
(or Brick Veneer)
- Recessed Façade at 10<sup>th</sup> Floor

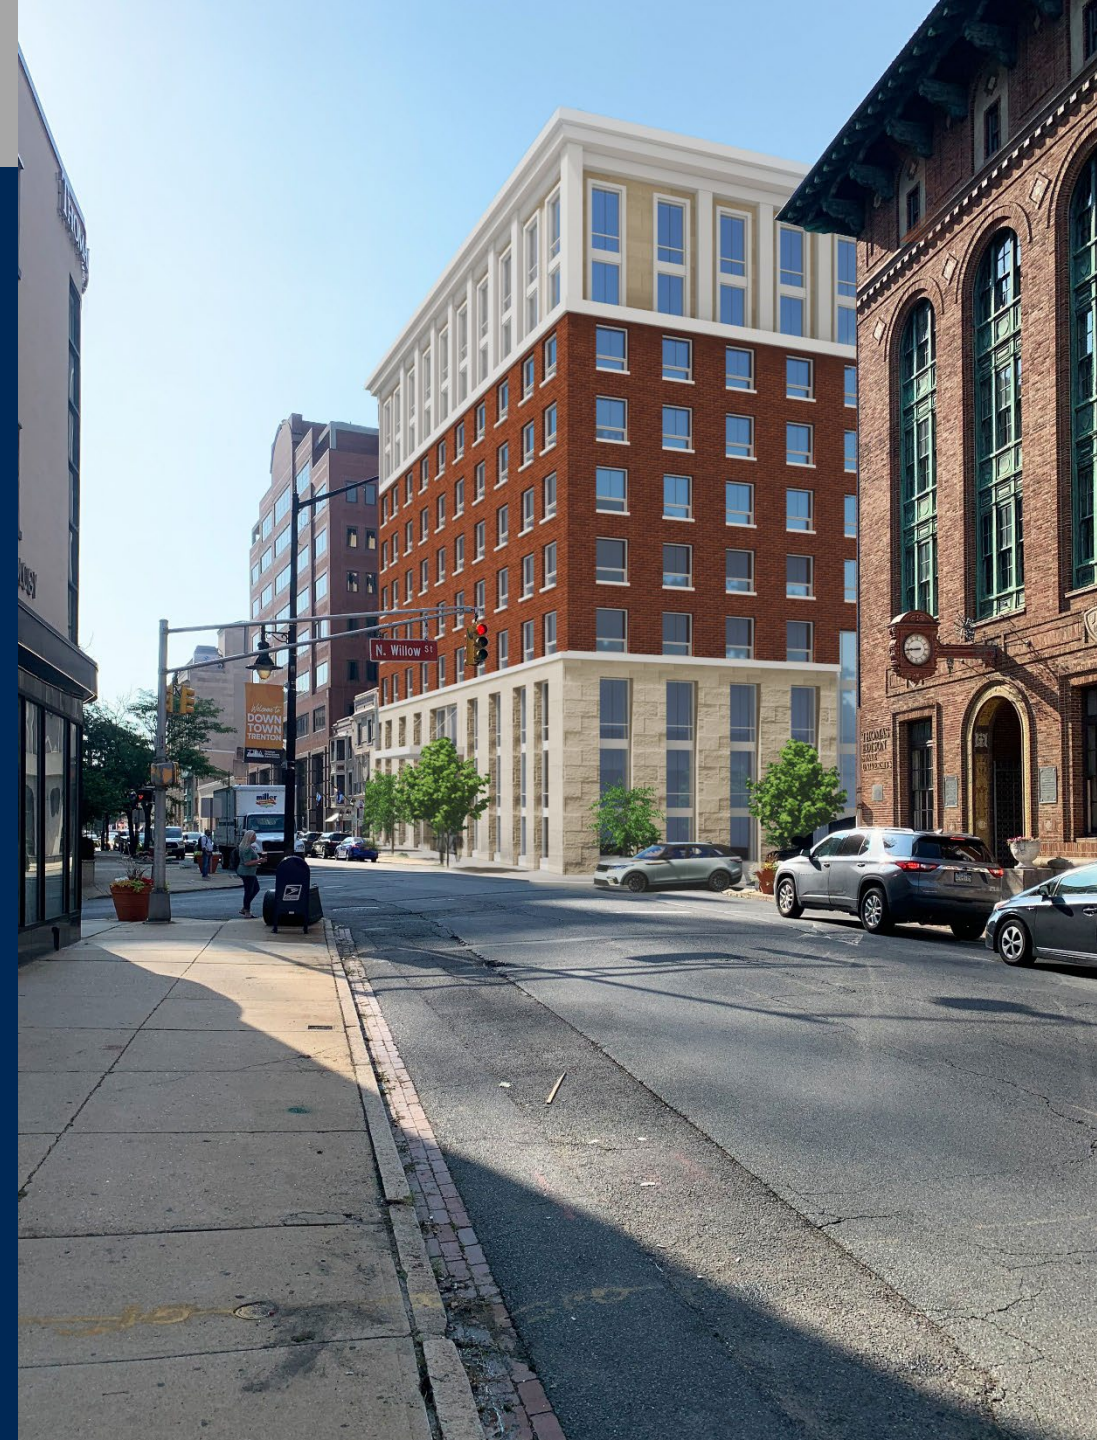
## 4D. Proposed Façade Treatment: OPTION 4

### New Façade at Floors 4-10

- Smaller-Scaled Operable Windows
- Brick Veneer and Stone Façade
- References the Stacy Trent Hotel  
Formerly at this Site
